October 10, 2008

Project:
Needs Analysis for Town Hall and Fire Station
Town Hall, and Central Fire Station
Whitman, MA

Town of Whitman
Needs Analysis for Town Hall and Fire Station

Existing Conditions
March 2008

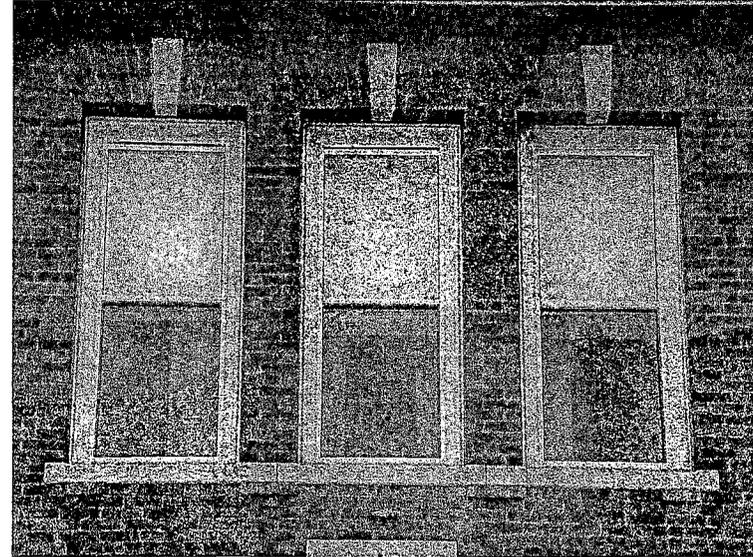
Replacement windows installed with metal casings.

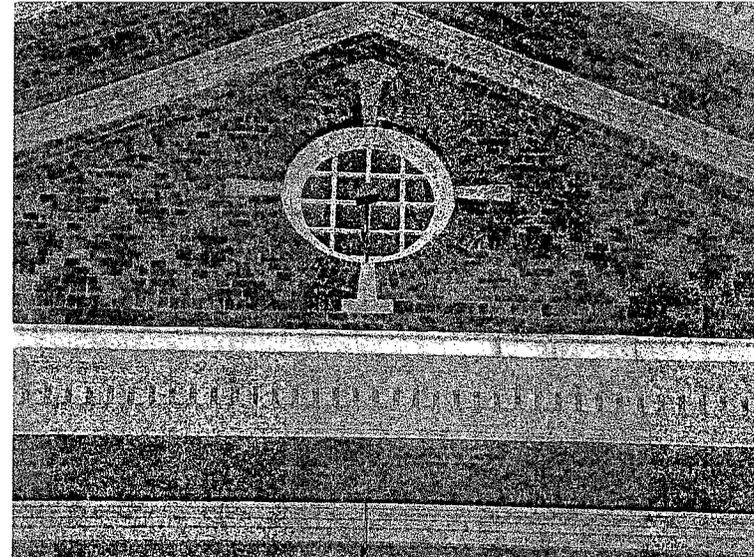
Ornamental brickwork in diamond pattern around circular window.

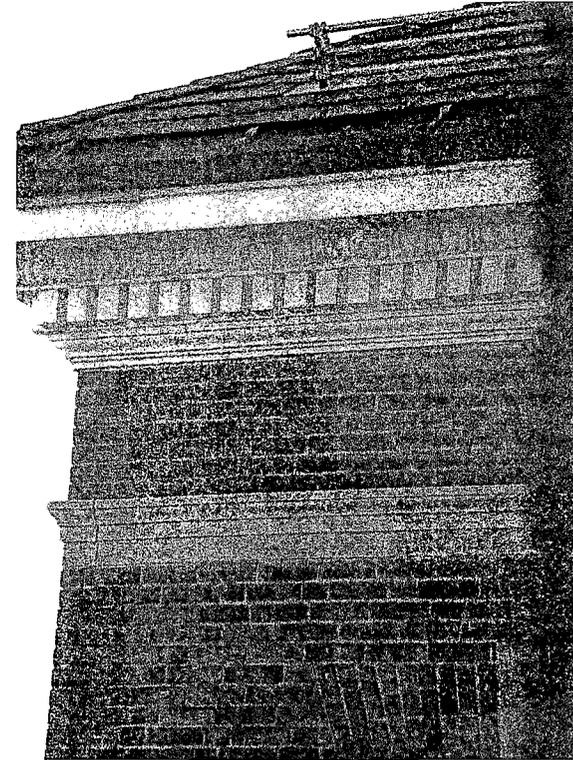
Deteriorated flashing at stone cornice banding.

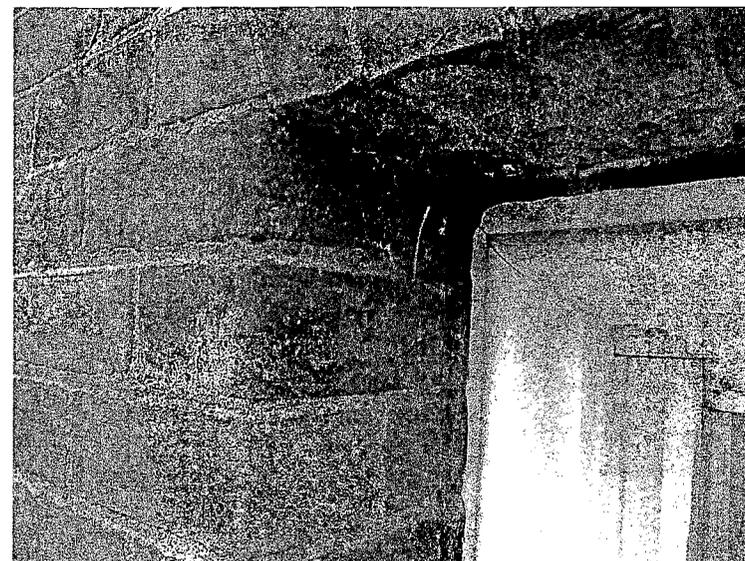
Two color caulking.

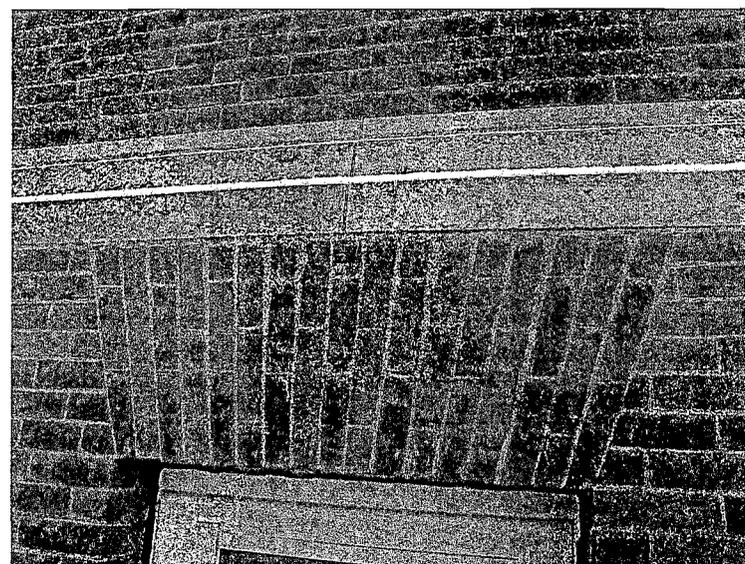
Fungi coated pre-cast stone belt course banding over architectural brick lintel.

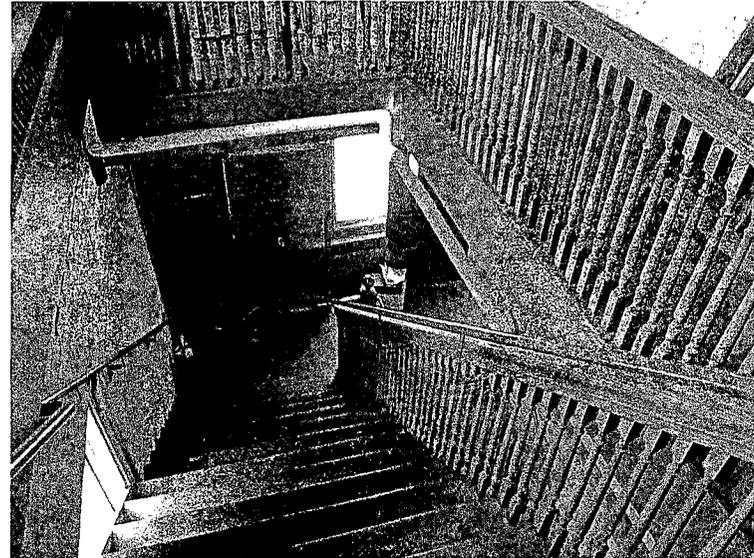
Northeast egress stairs.

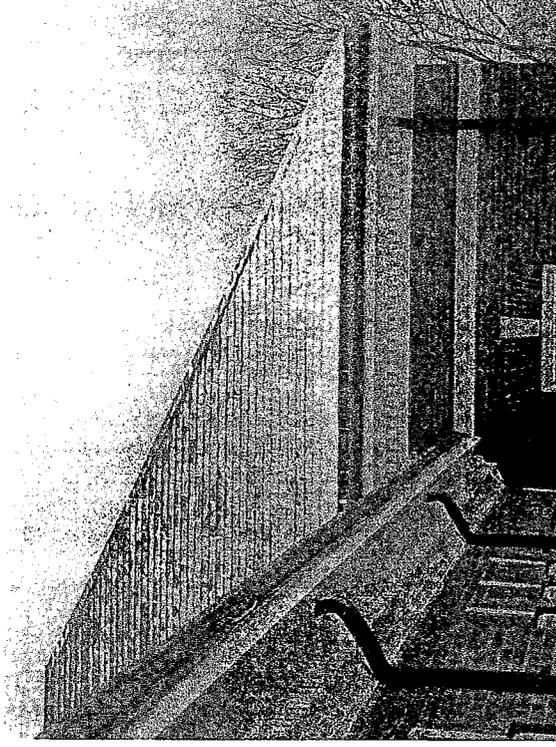
Metal cornice with hidden gutter.

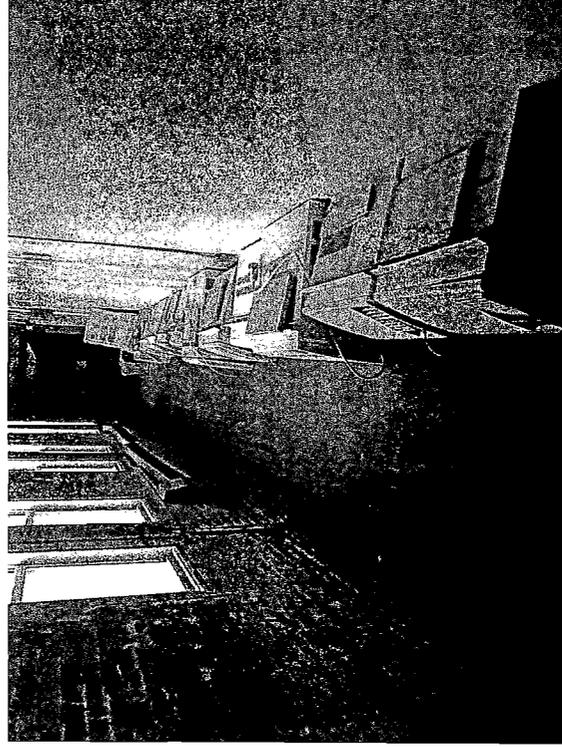
Back stage passage, loose paint on masonry walls.

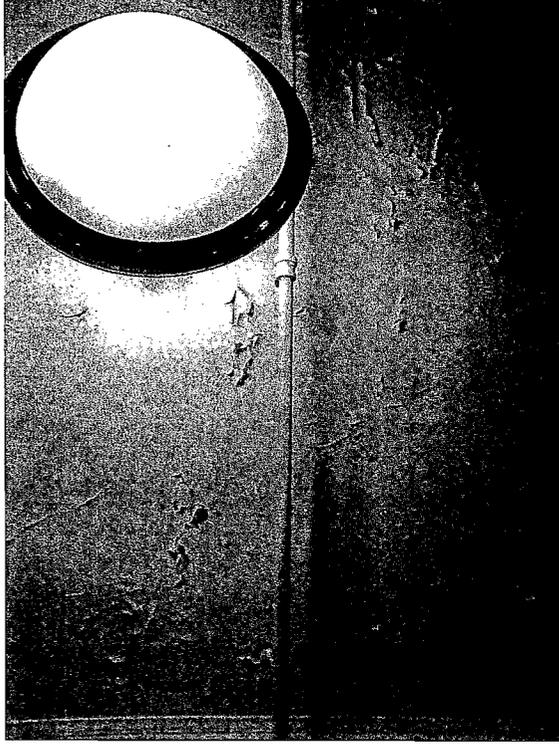
Loose peeling paint.

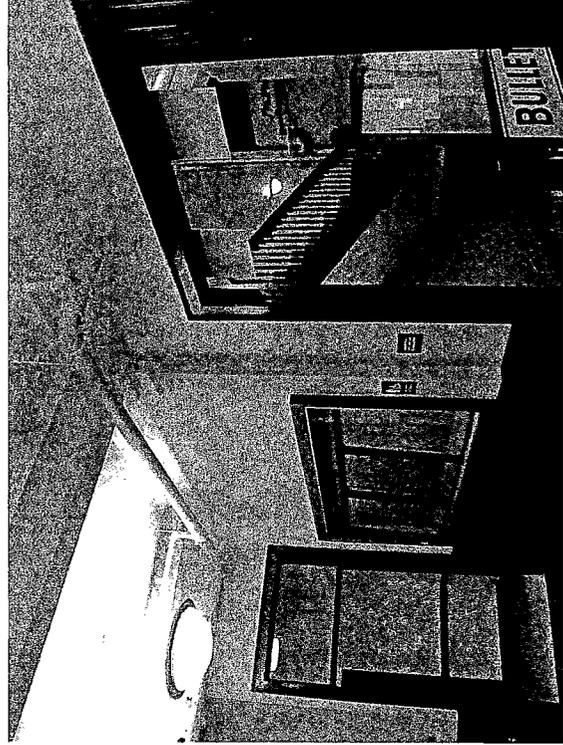
Loose peeling paint near elevator.

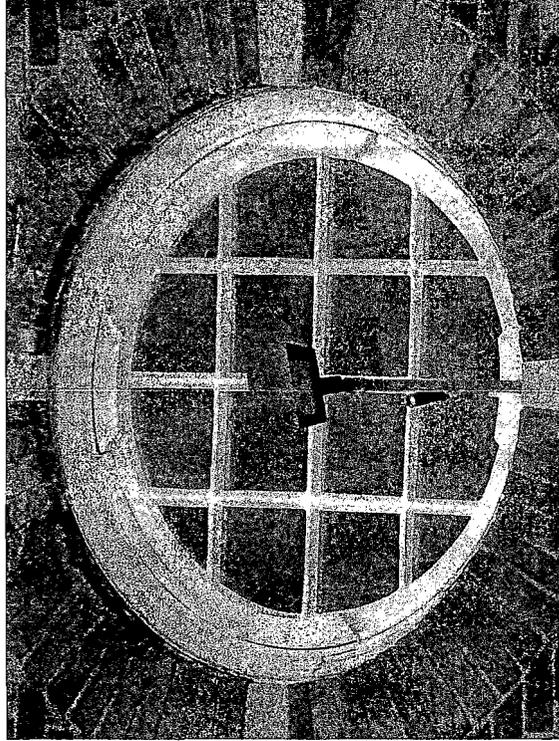
Elliptical muntin and mullion window, open joints next to brick.

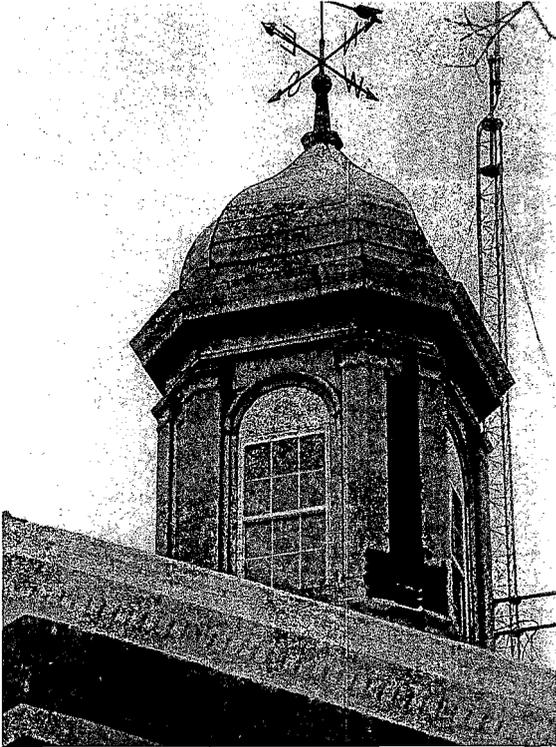
Replacement windows covering previous air louvers. Upper metal covering wood frame cupola deteriorating.

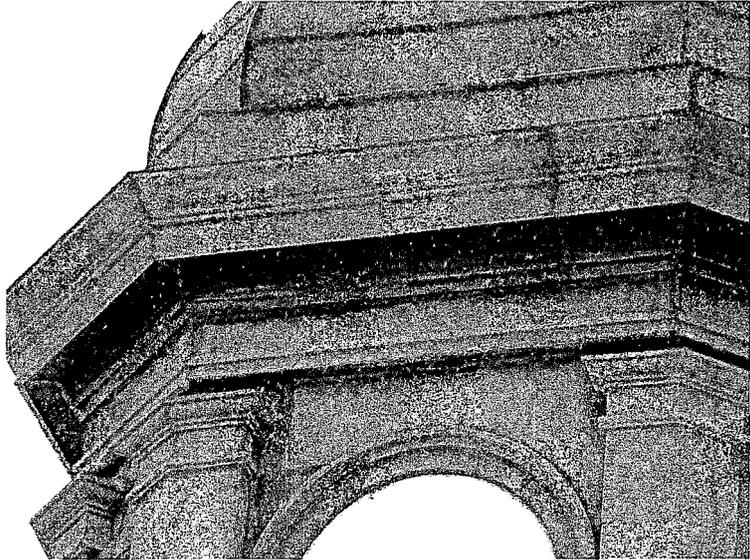
Metal banding deteriorating at joints

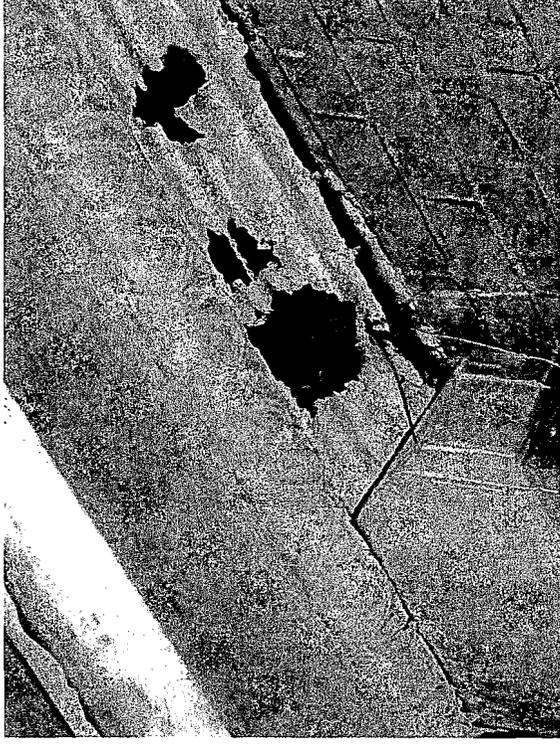
peeling paint and rusting crown molding under soffit

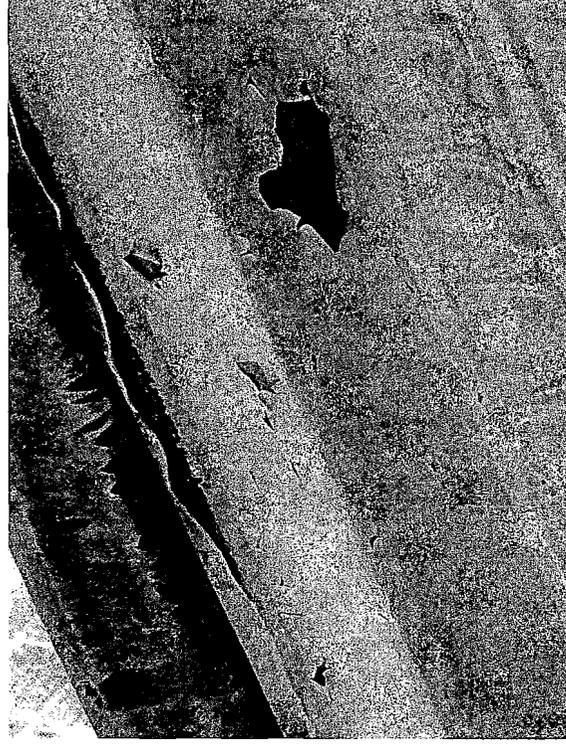
Peeling paint and rusting crown molding under soffit.

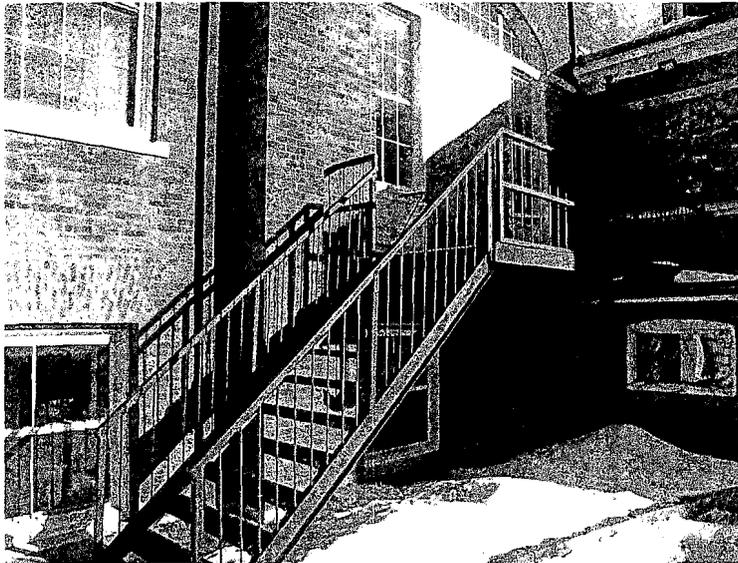
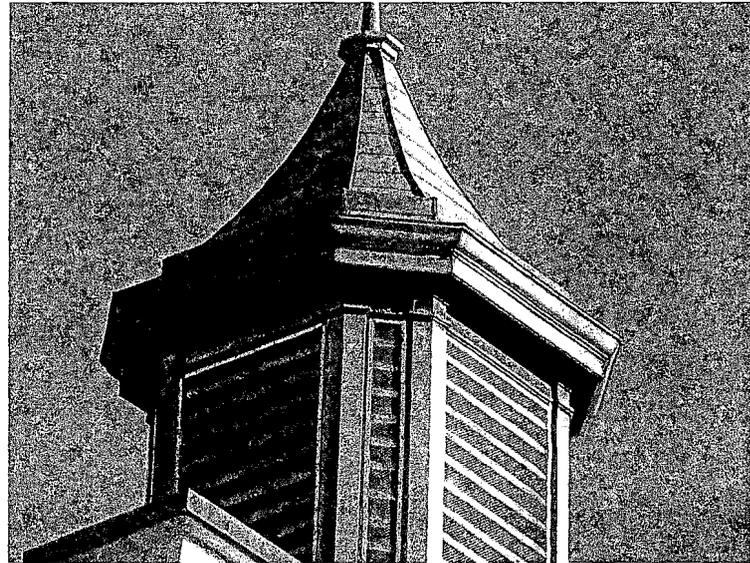
Deteriorating metal on auditorium ventilator.

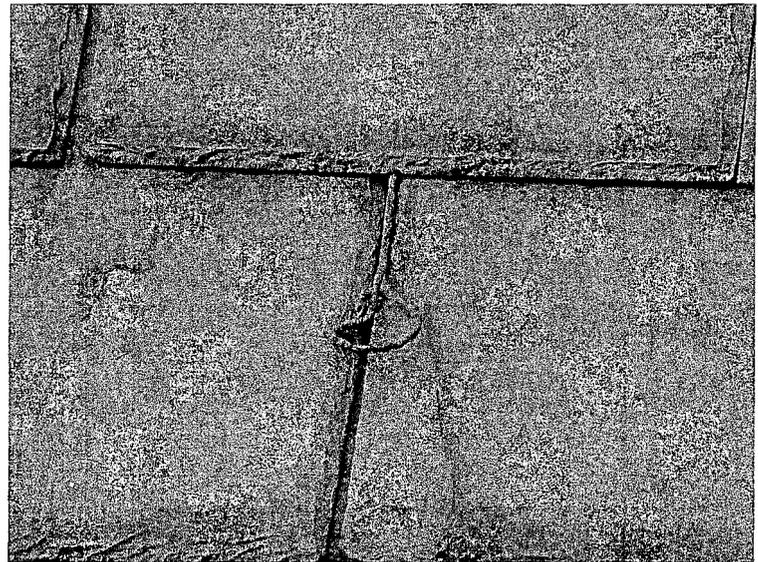
Rusted and broken snow guard, cracked slate.

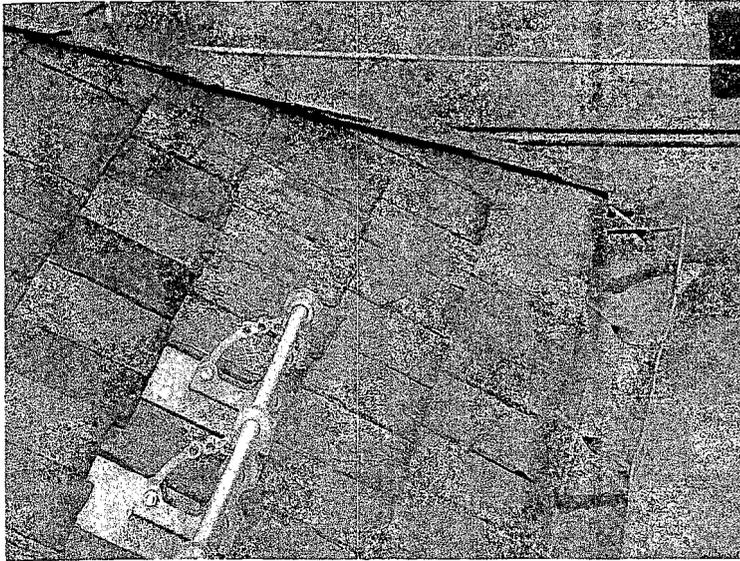
Loose slate at northeast ridge. Corner ridge cap appears loose.

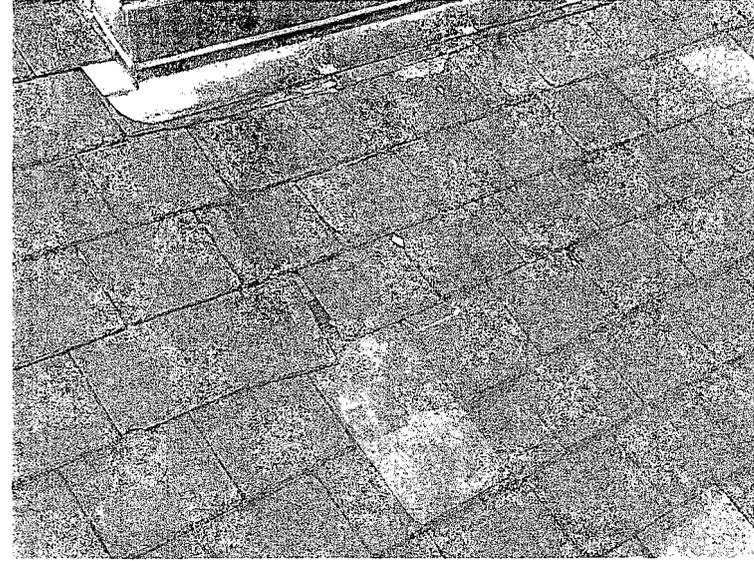
Loose broken slate at chimney.

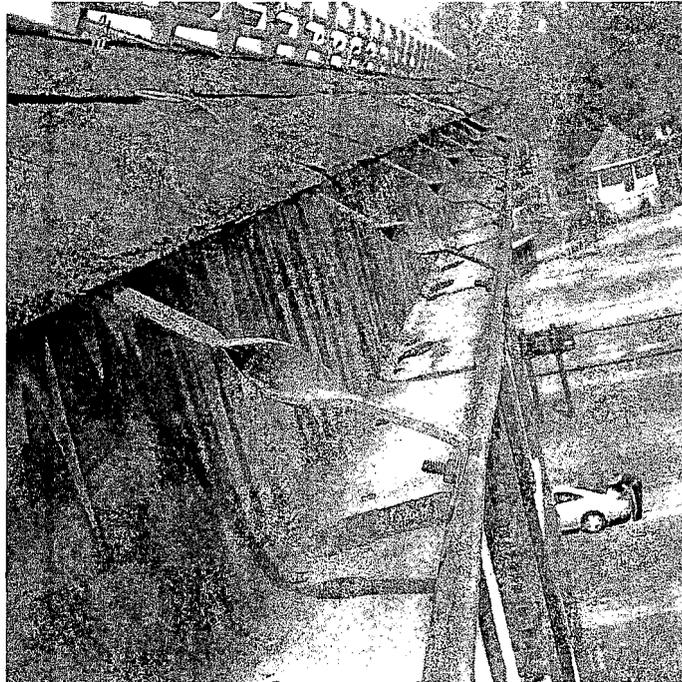
Original gutter with numerous hole perforations allows water to penetrate into structural brick wall below.

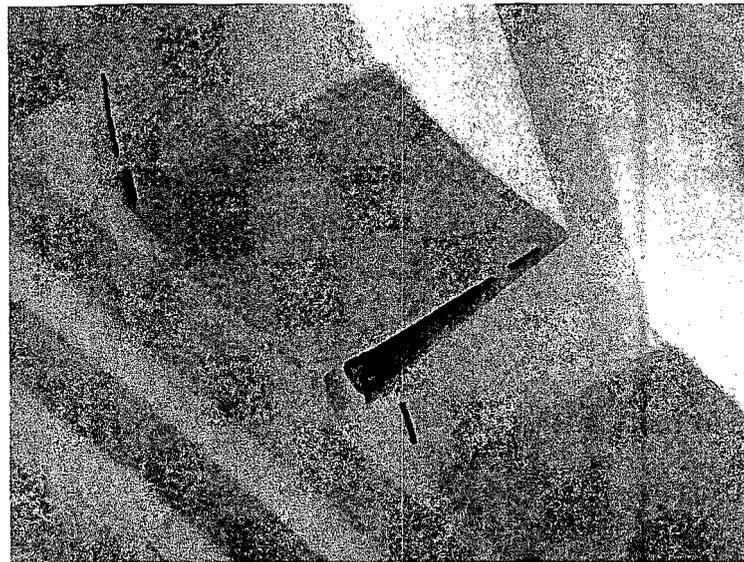
Metal cornice dentil loss of attachment.

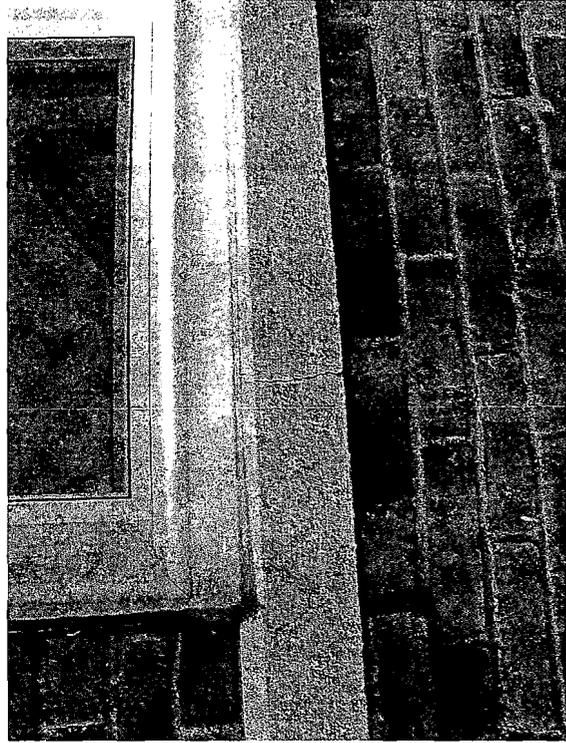
Cracked limestone sill

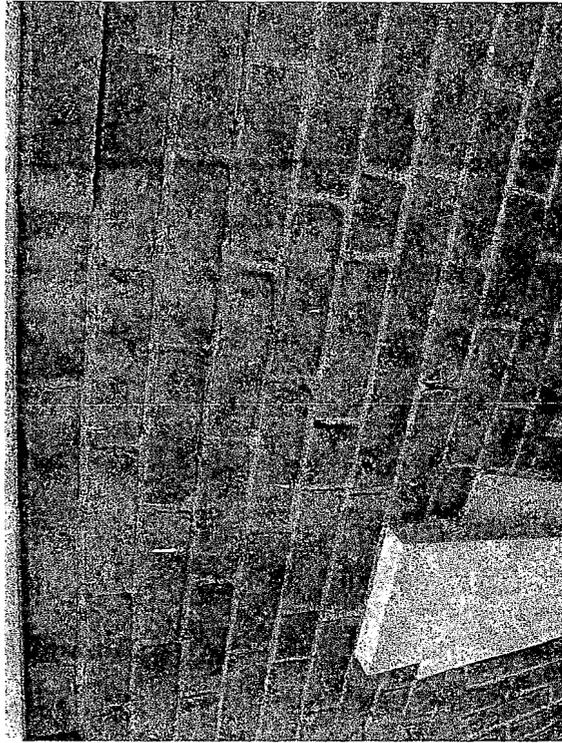
"whitewashed" brick caused by low quality window paint. Thinning, bleeding, and washing of paint over time has left paint staining marks on majority of bricks below the sills,

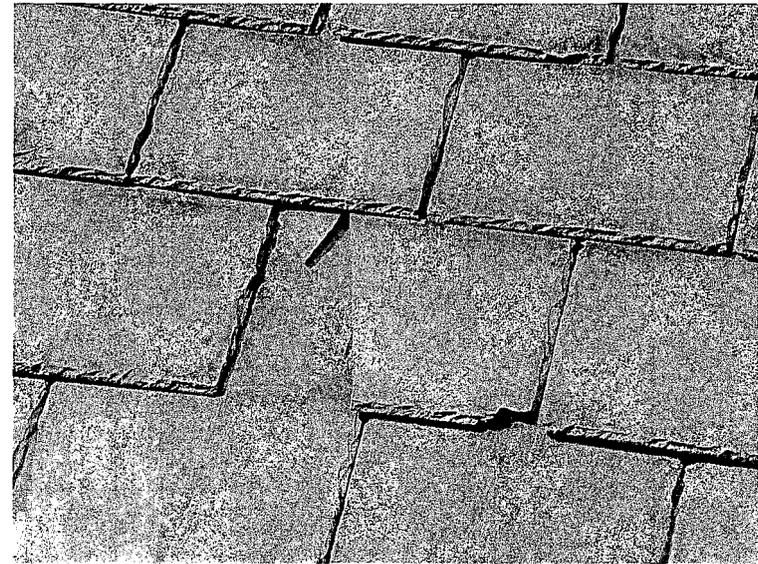
Typical broken slate.

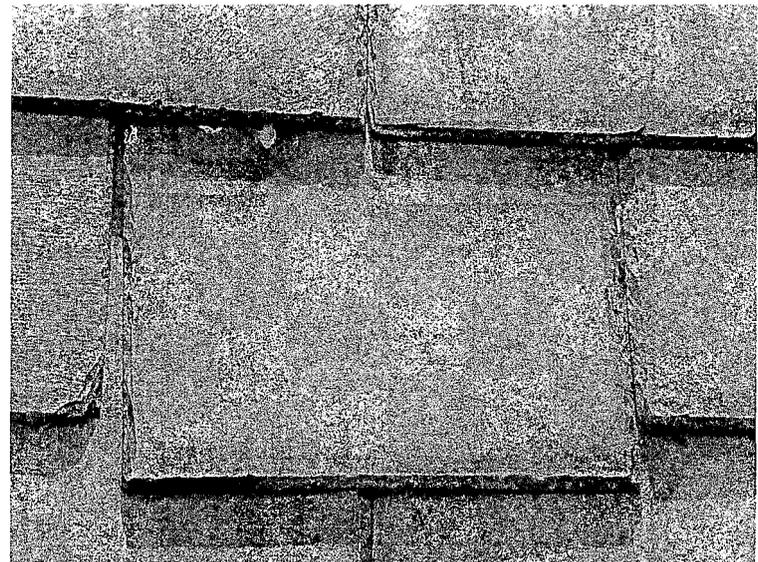
Example of slate nail fastener failure.

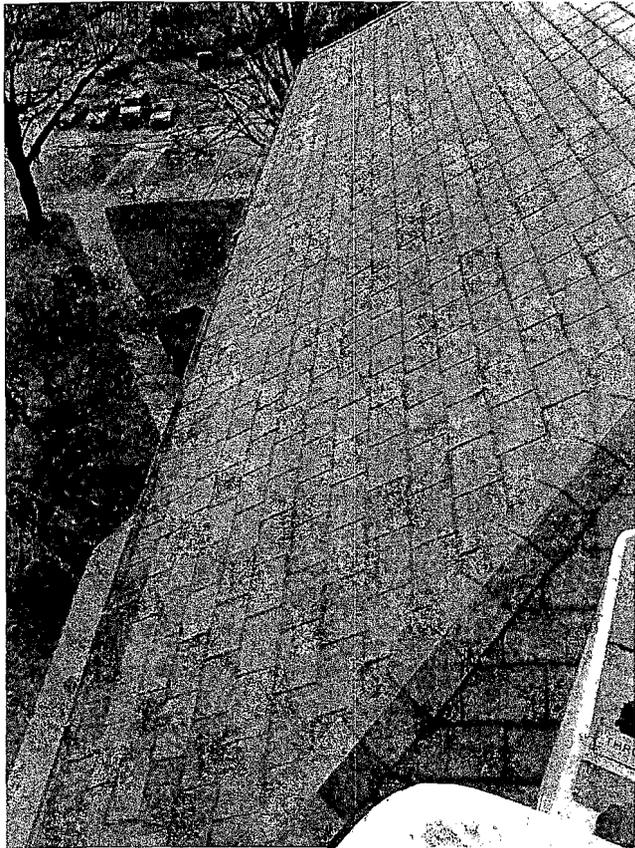
Southeast roof showing replacement slate repairs, old gutter system

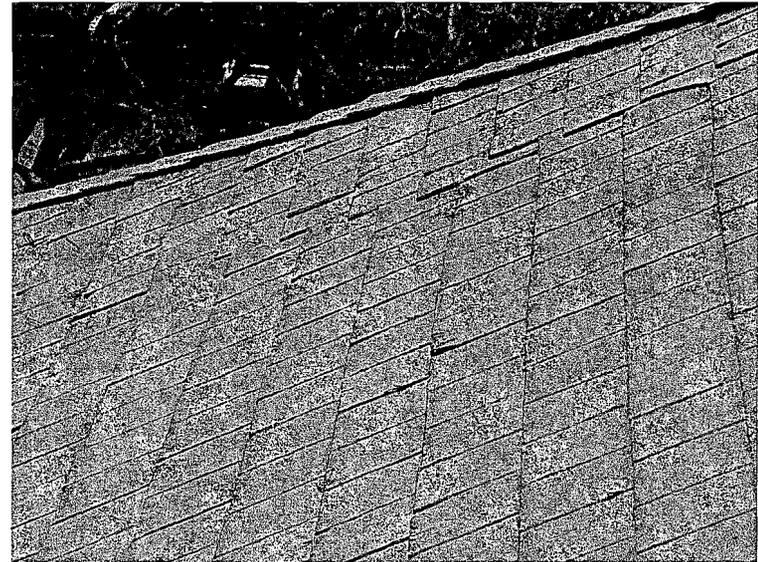
Loose slate on southeast corner.

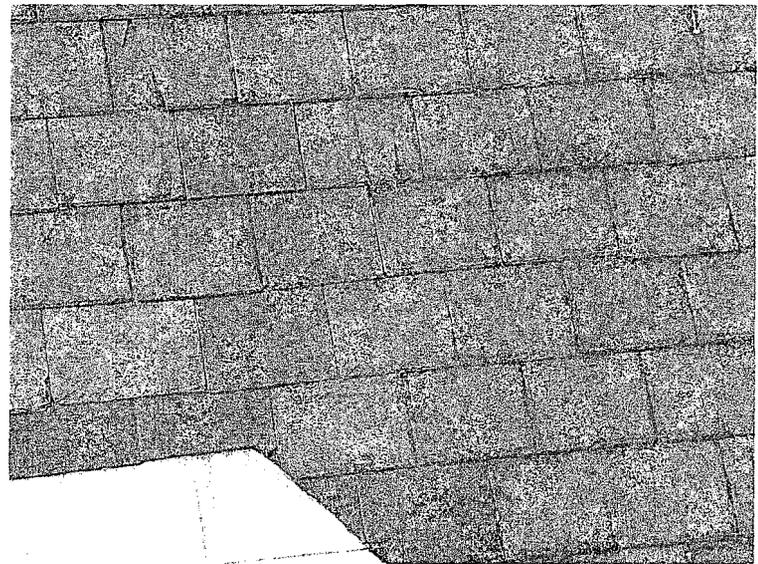
Loose cracked and repaired slate.

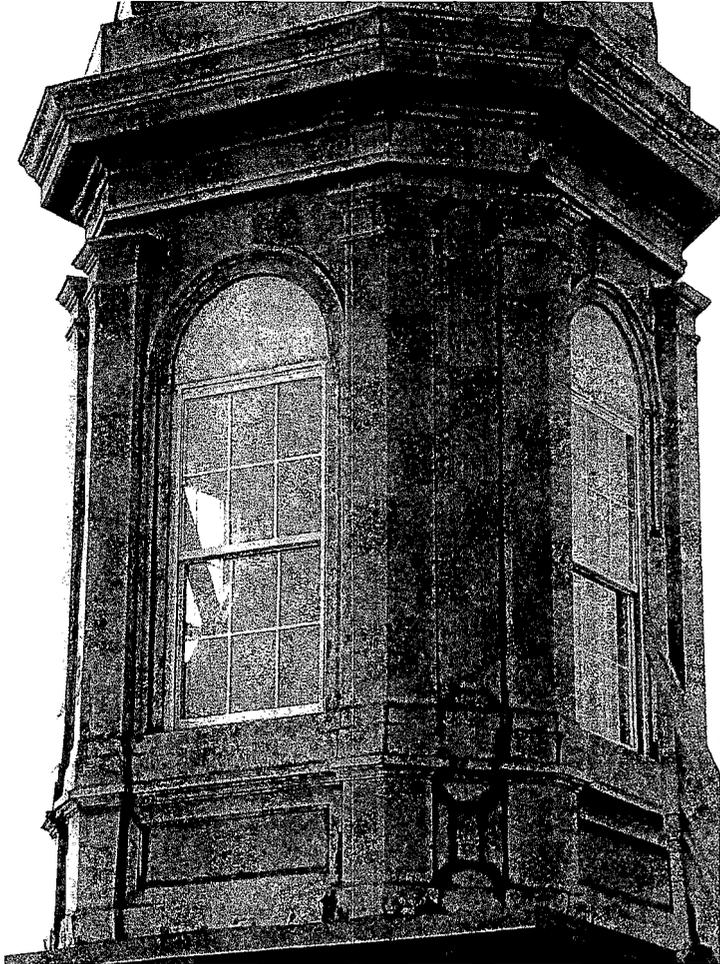
South cupola architectural metal detail, most joints are deteriorated.

At the South elevation the metal architecturally detailed cupola is badly deteriorated after 101 years. It is understood cupola repairs performed roughly 8 years ago was only to seal the leaking cupola base. Access to observe existing conditions was available. It was observed the mini truss system supporting the cupola is in satisfactory condition, however the wood studs and sheathing should be replaced when re-sheathing the cupola in metal. There is apparent water damage to the plaster face wrapped structural wood beam at the second floor coffered ceiling. Further investigation, including removing the plaster for observation in the schematic design stage is recommended.

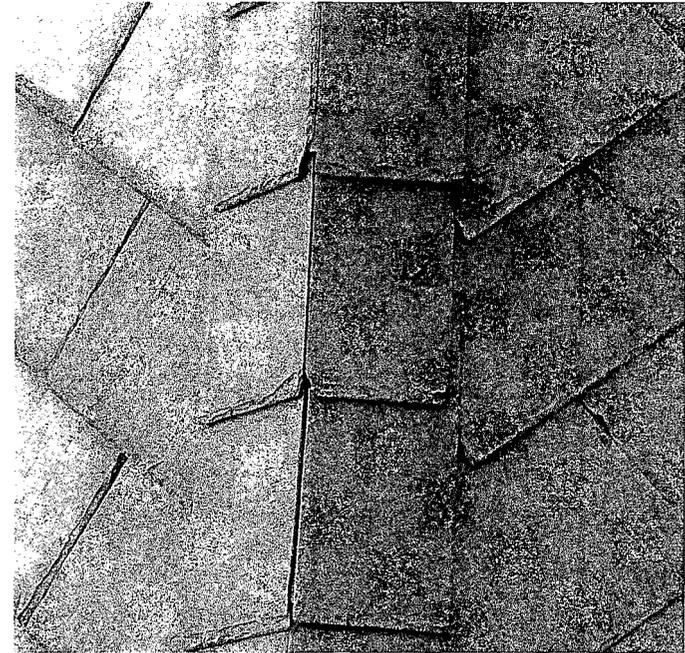
Open ridge caps.

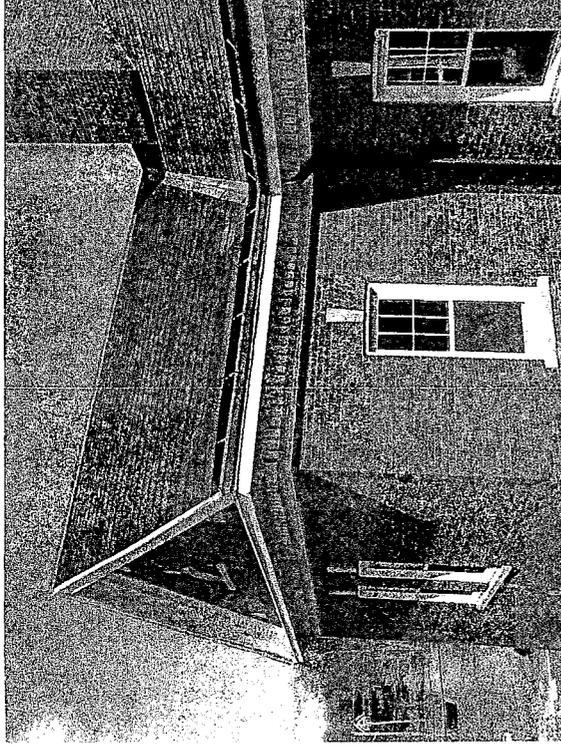
Northwest gable with cracked and missing slate. Gutter has been patched.

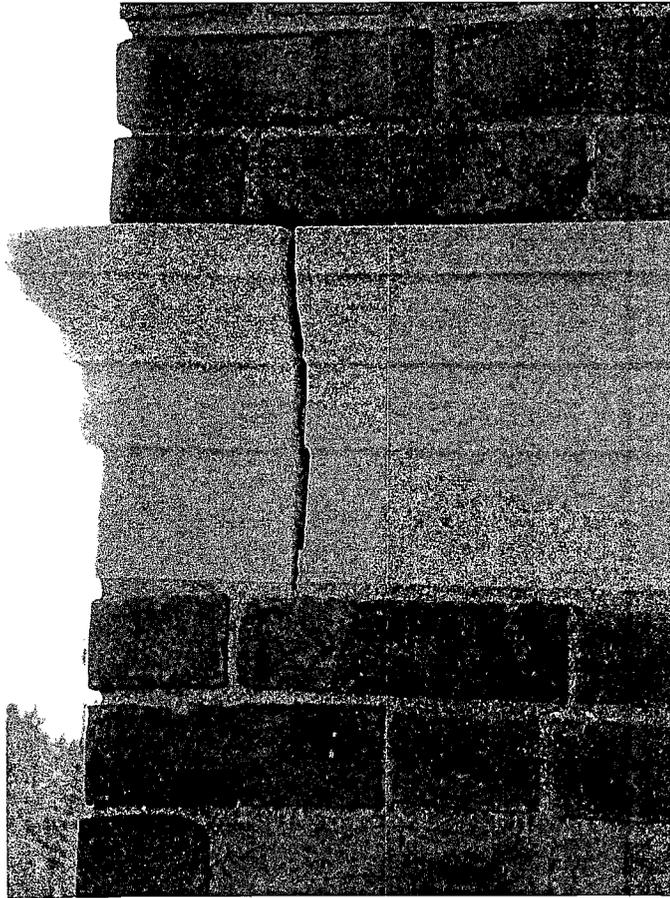
Open limestone cornice connections allowing water to penetrate into building.

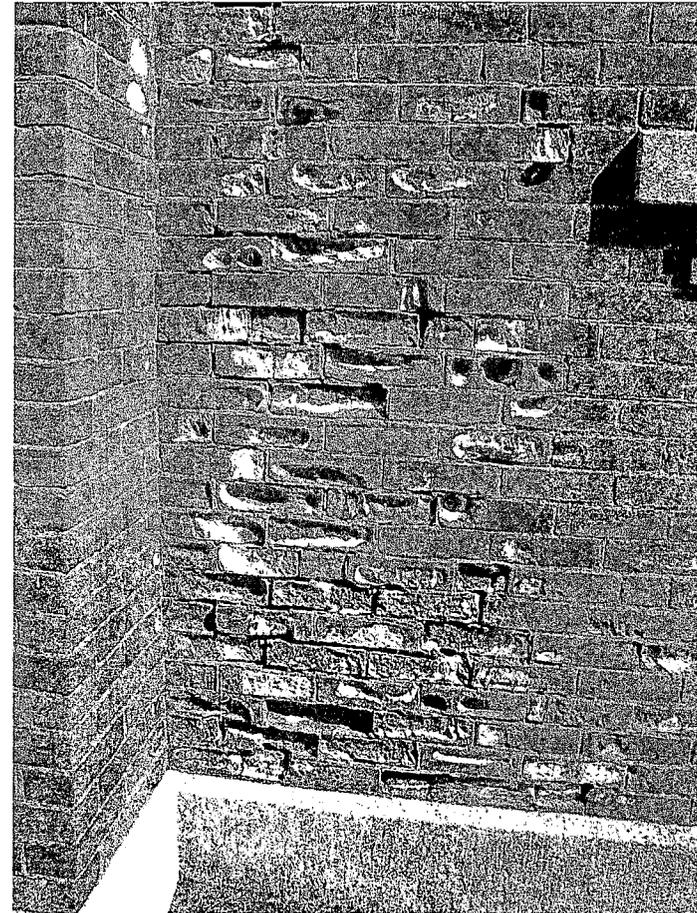
Severe spalling brick masonry wall at west elevation of port cochere.

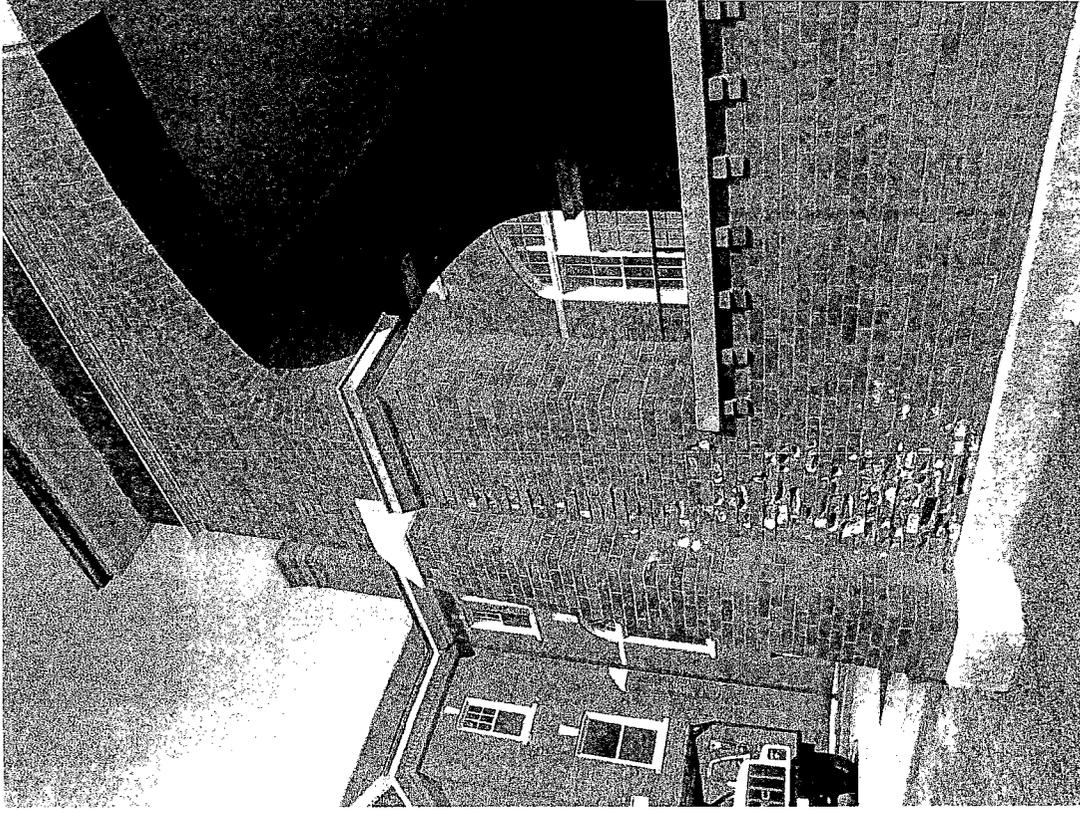
Porte cochere masonry wall of west elevation. Brick spalling runs vertically from cornice to foundation wall.

Due to the suggested partial brick replacement of the West elevation at the Porte Cochere, the top West and North masonry wall should be rebuilt with five or six courses (or as needed) to close the loss of mortar openings at the roof level. The entire roof perimeter must be opened and replaced with new roof accommodating the original flashing features. New BUR replacement roof with stone ballast or PVC membrane recommended with tapered isocyanurate insulation for 20-30 year life.

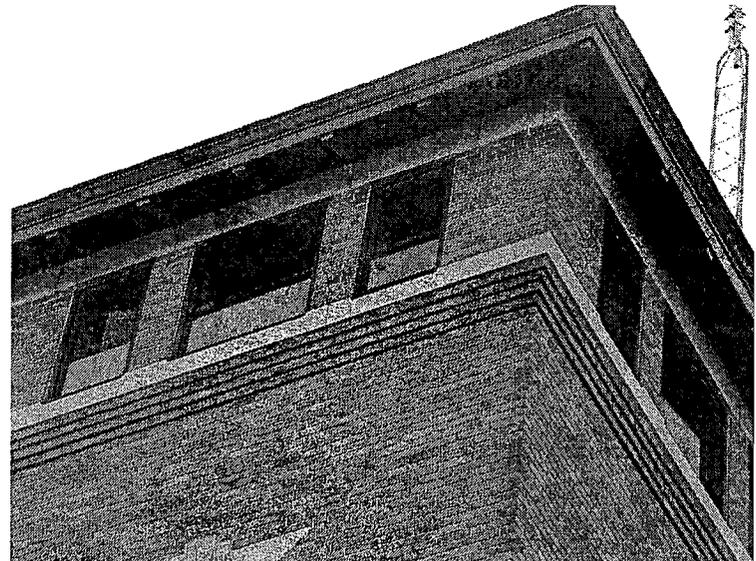
Deteriorating cornice.

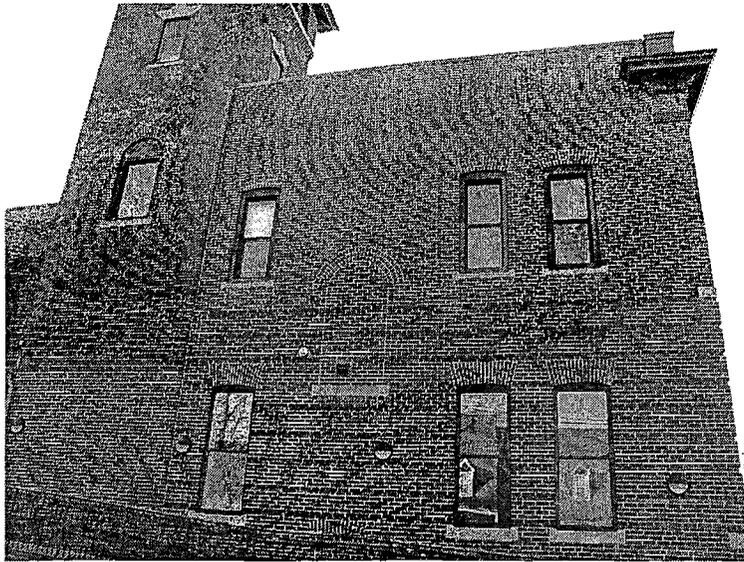
East elevation, loose deteriorating mortar.

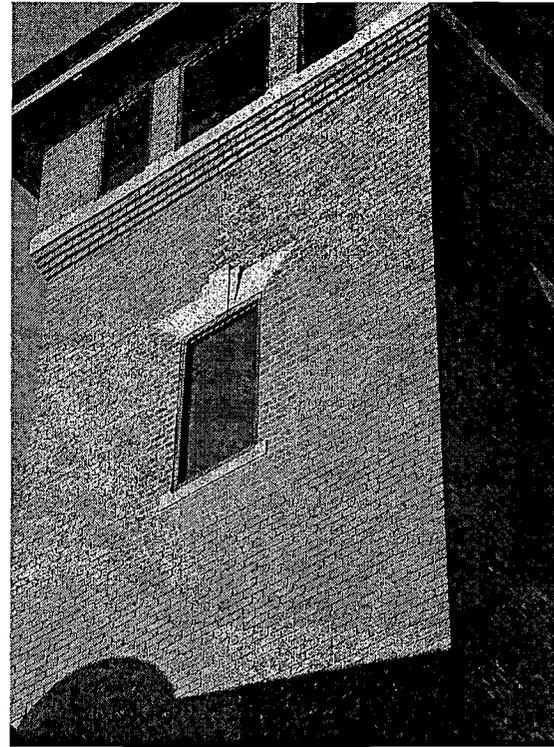
Deteriorated mortar.

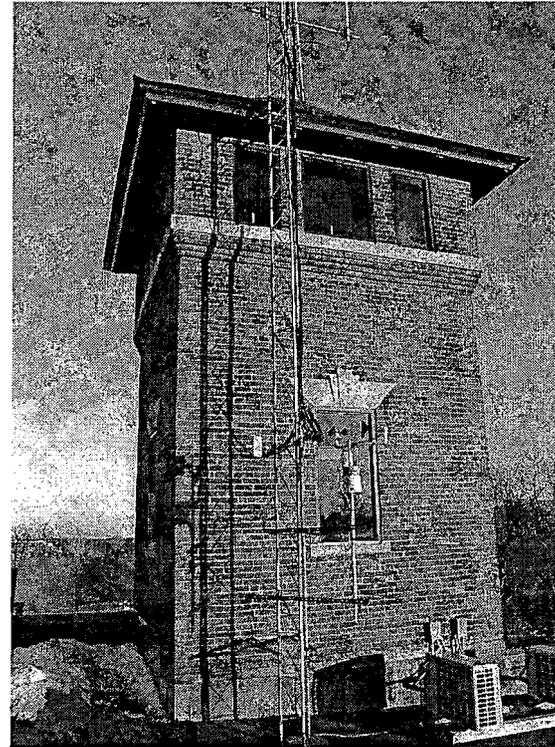
Deteriorated mortar at upper window.

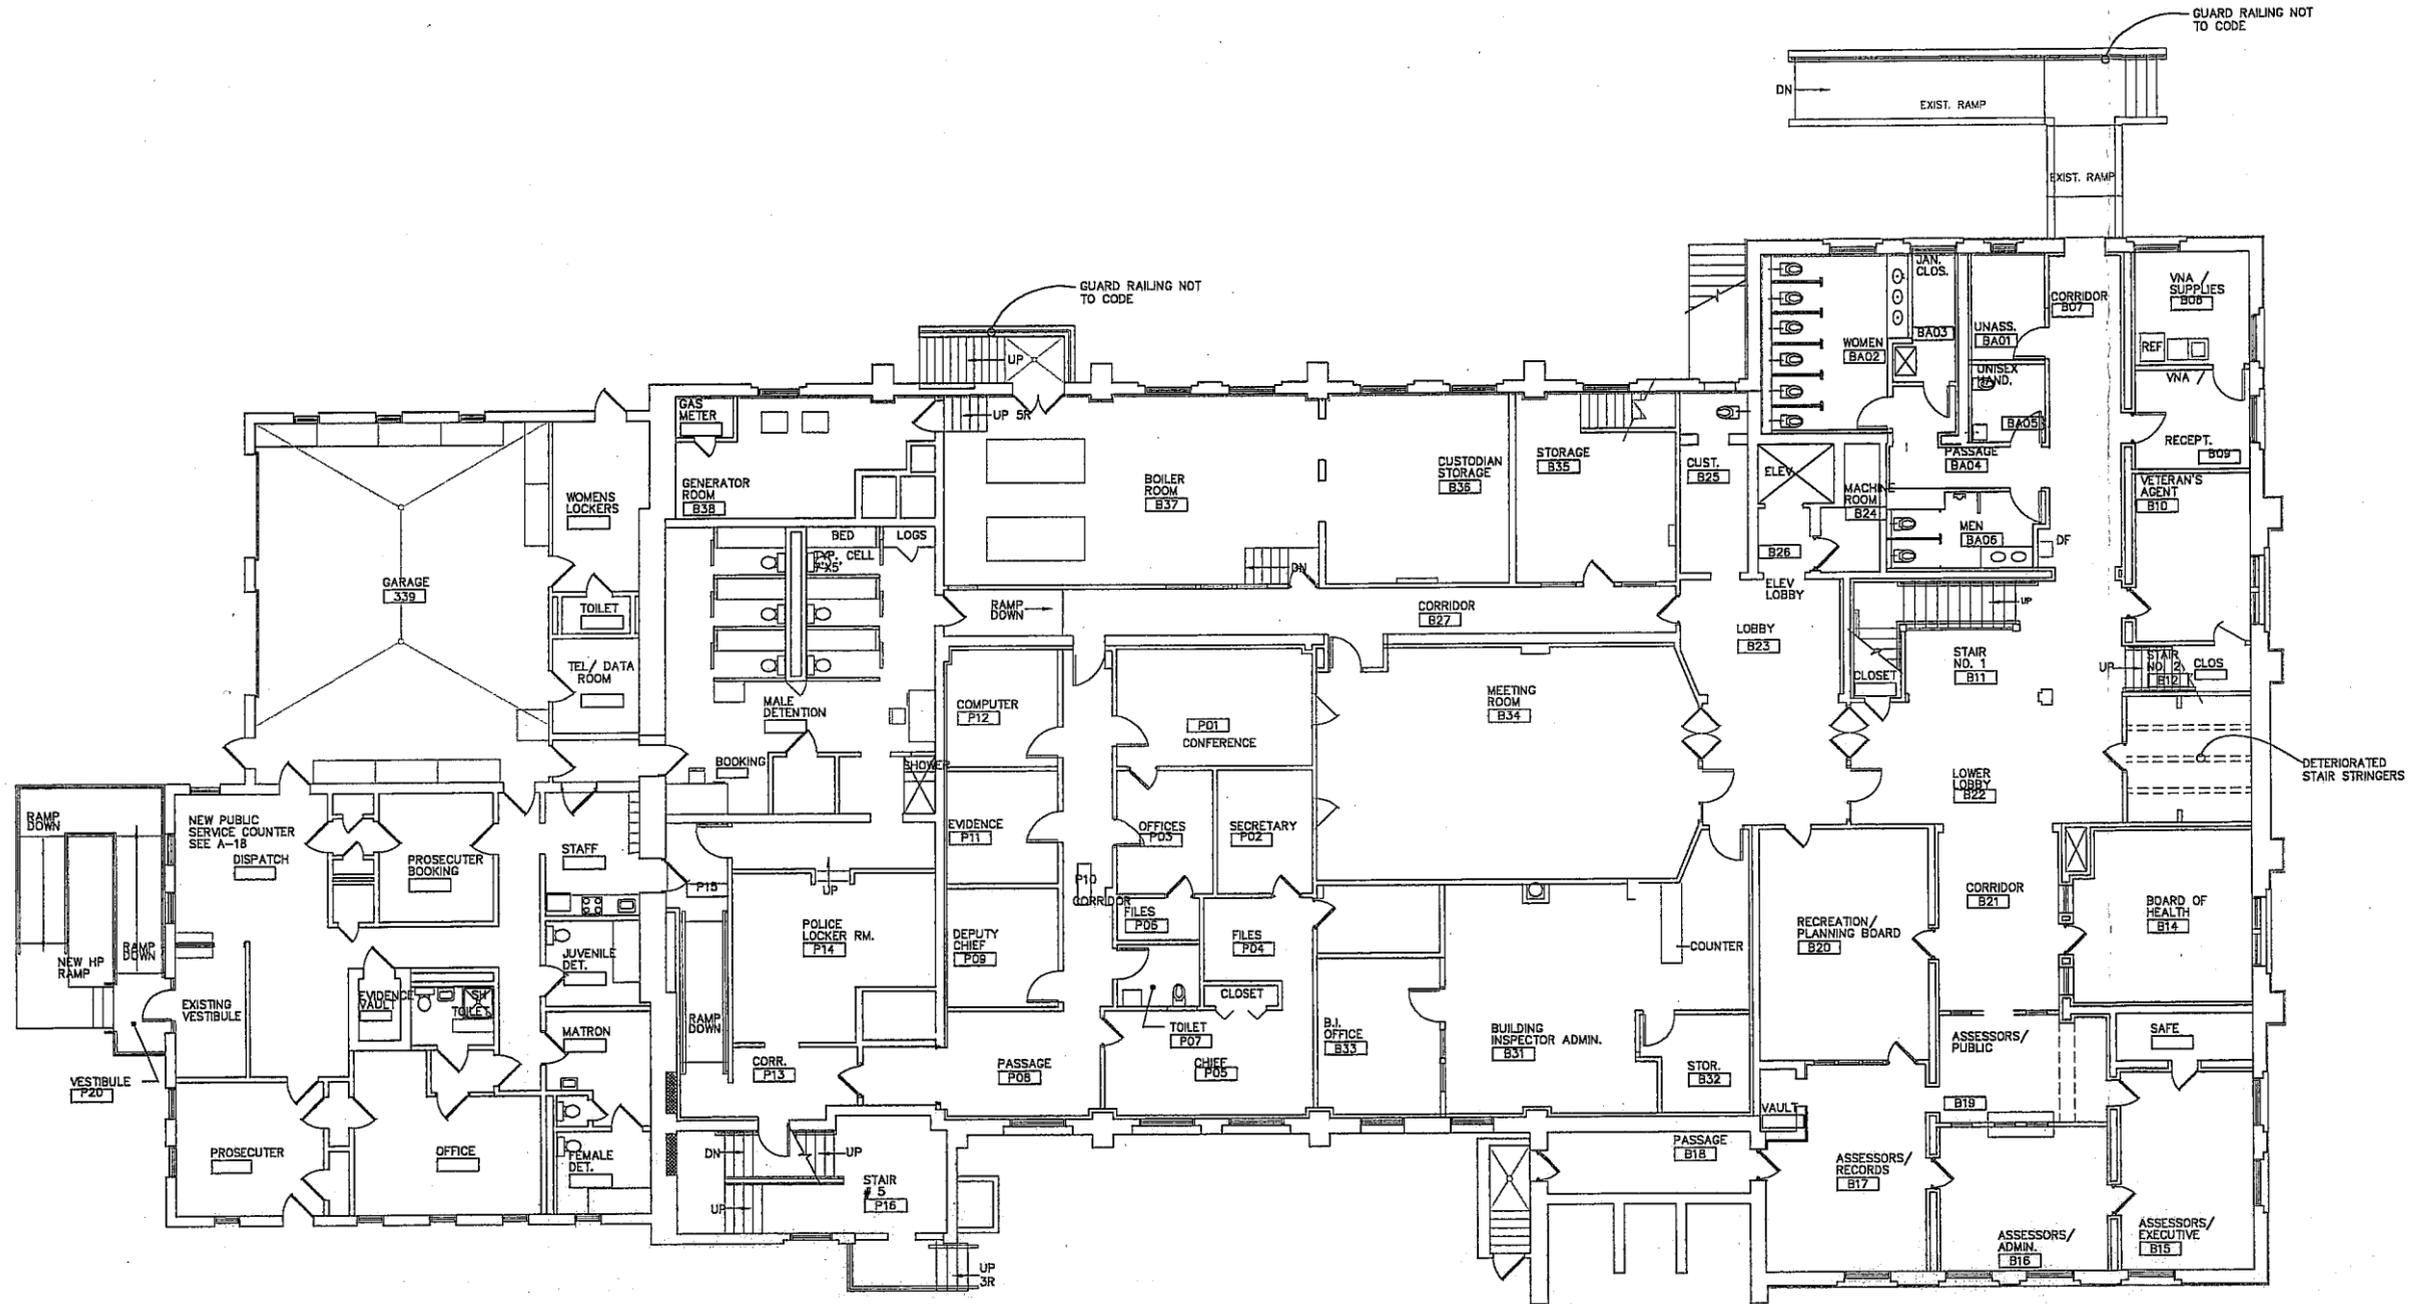
1 EXISTING CONDITIONS GROUND FLOOR PLAN
EX1.0 SCALE: 1/8" = 1'-0"

NOTE:
PEELING CEILING PAINT IN CORRIDORS,
OFFICES, AND AUDITORIUM-1729 SF
