October 10, 2008

Project:
Needs Analysis for Town Hall and Fire Station
Town Hall, and Central Fire Station
Whitman, MA

Town of Whitman
Needs Analysis for Town Hall and Fire Station

Existing Conditions
March 2008

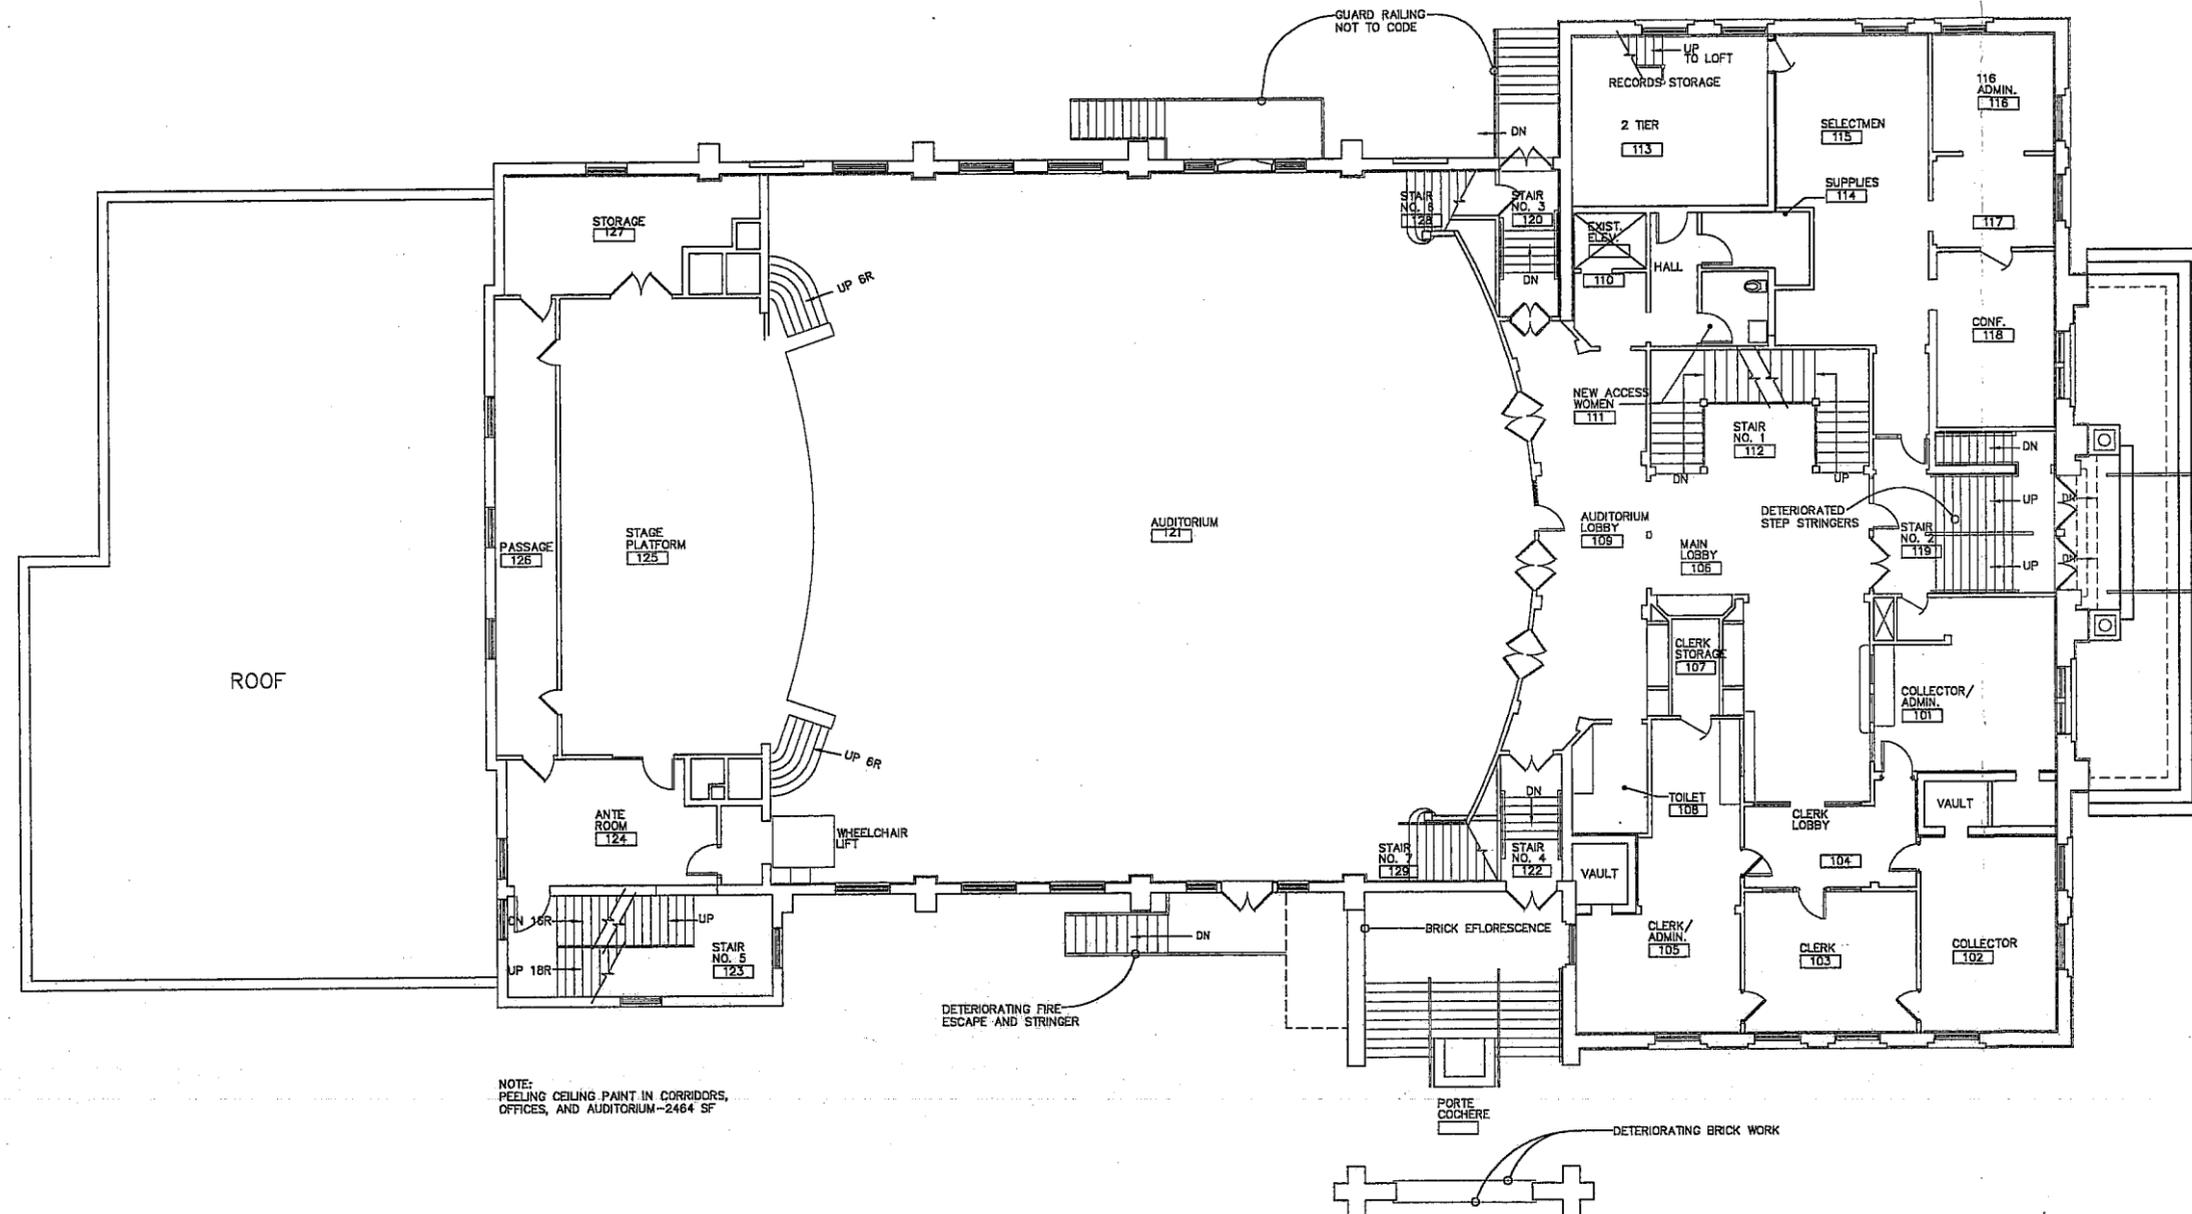
1 EXISTING CONDITIONS FIRST FLOOR PLAN
EX1.1 SCALE: 1/8" = 1'-0"

NOTE:
PEELING CEILING PAINT IN CORRIDORS,
OFFICES, AND AUDITORIUM-2464 SF
