First Baptist Church Building:

First Baptist Church  
Whitman, MA

**FINAL REPORT  
FOR  
ASBESTOS CONTAINING MATERIALS  
IDENTIFICATION SURVEY  
AT  
FIRST BAPTIST CHURCH  
WHITMAN, MASSACHUSETTS**

Town of Whitman  
 First Baptist Church  
*Investigation and Report*

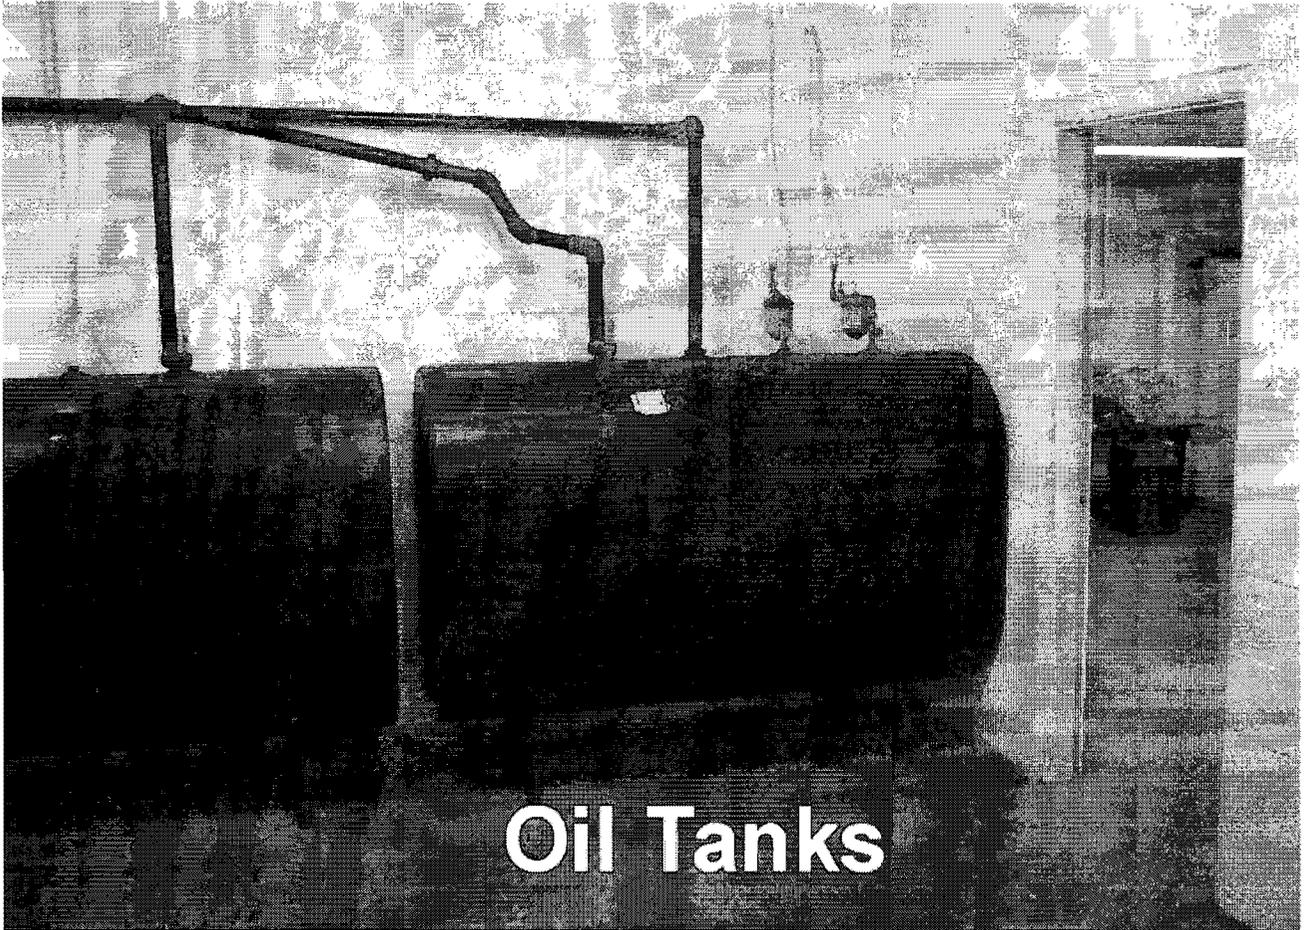
**Oil Tanks**

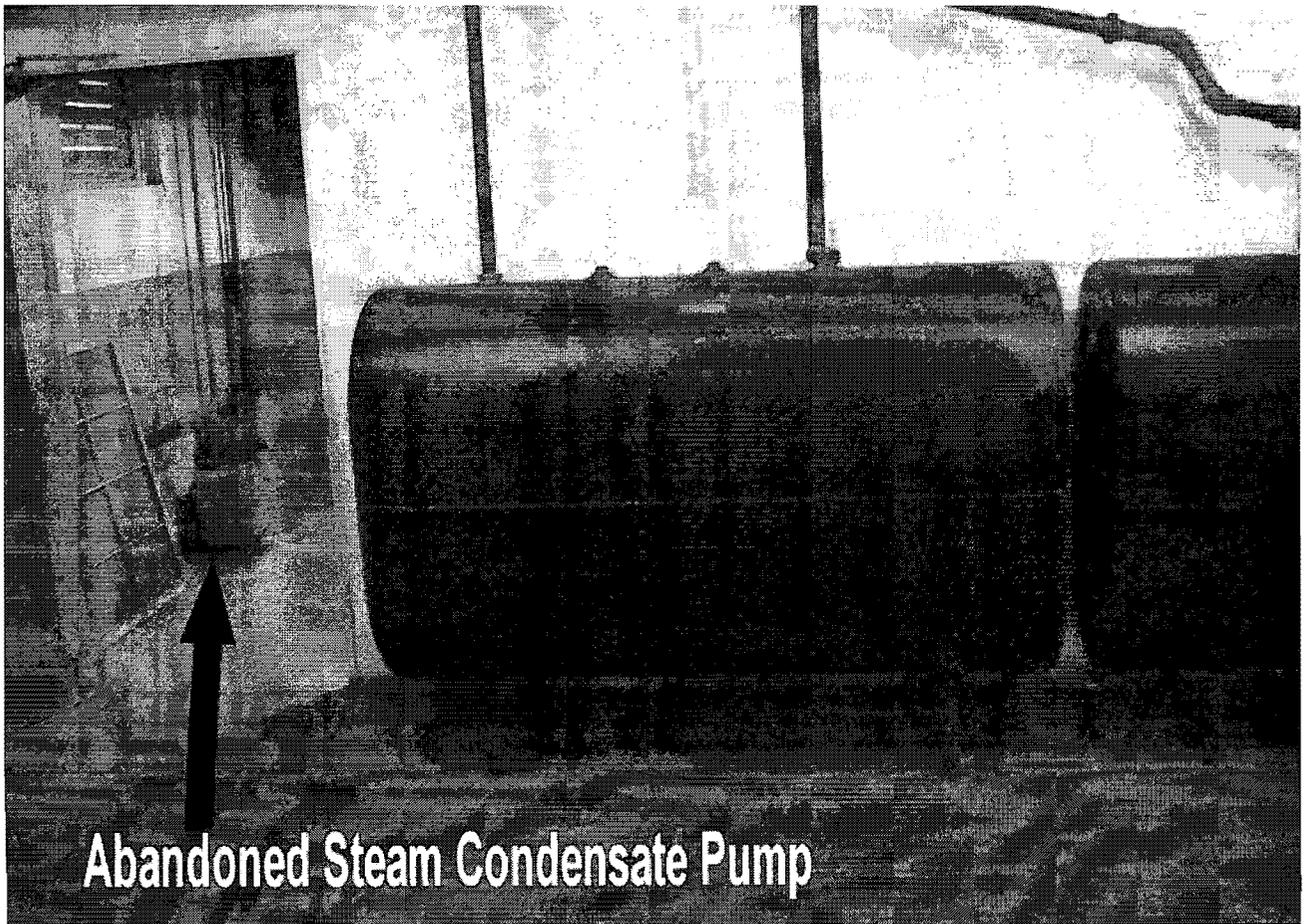
**Abandoned Steam Condensate Pump**

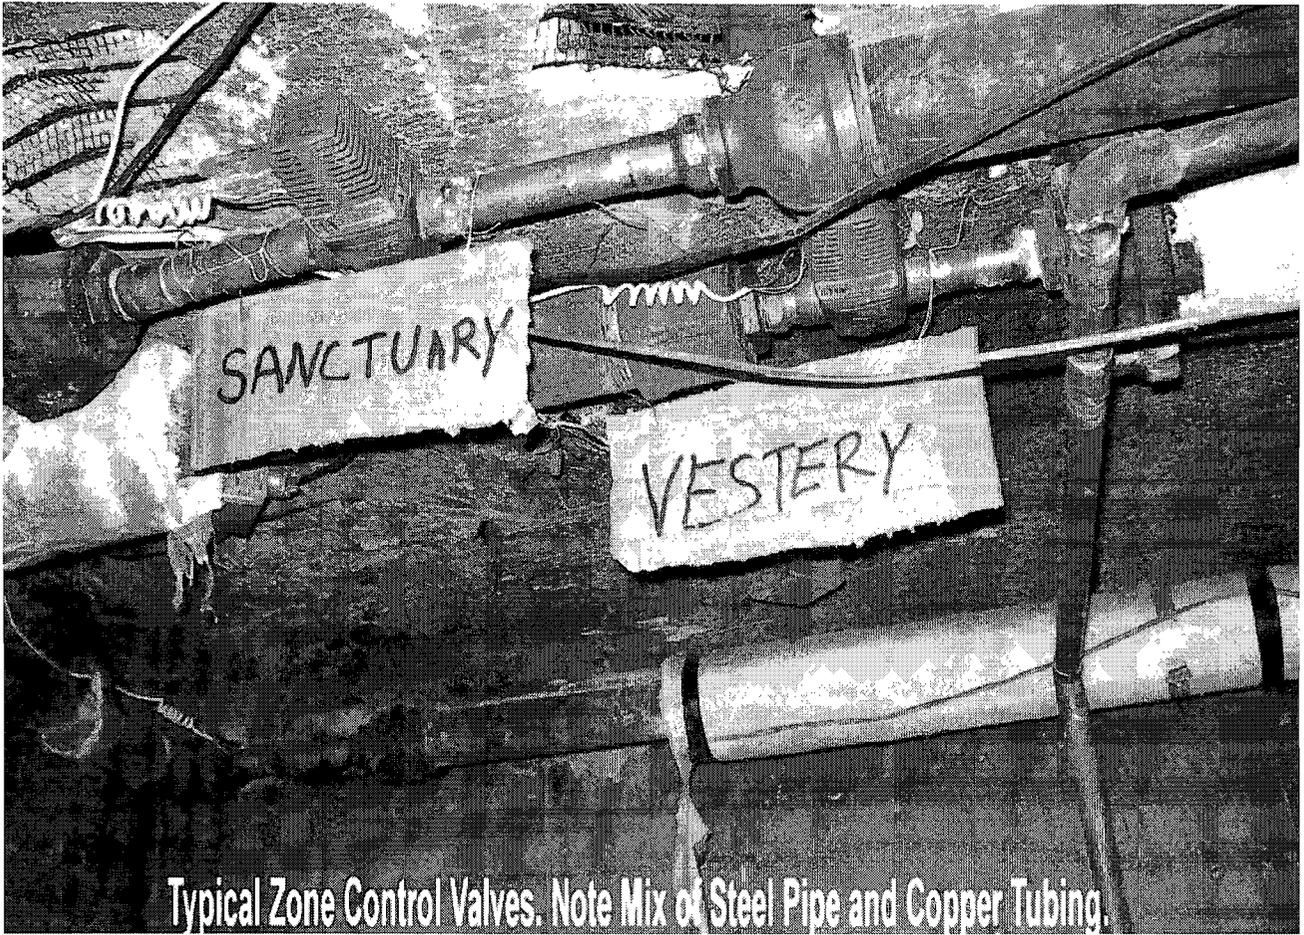
The old steam system was converted to hot water. There are currently six heating zones, each with a residential quality zone control valve. The hot water circulation and return piping is undersized. Newer work is in copper. The older steam system is steel. There appears to be some asbestos pipe insulation.

Typical Zone Control Valves. Note Mix of Steel Pipe and Copper Tubing.

The entire system should be replaced with a modern HVAC system. The final layout, use of space, etc. should be used to determine the type of system. However, a hydronic system in some form is recommended.

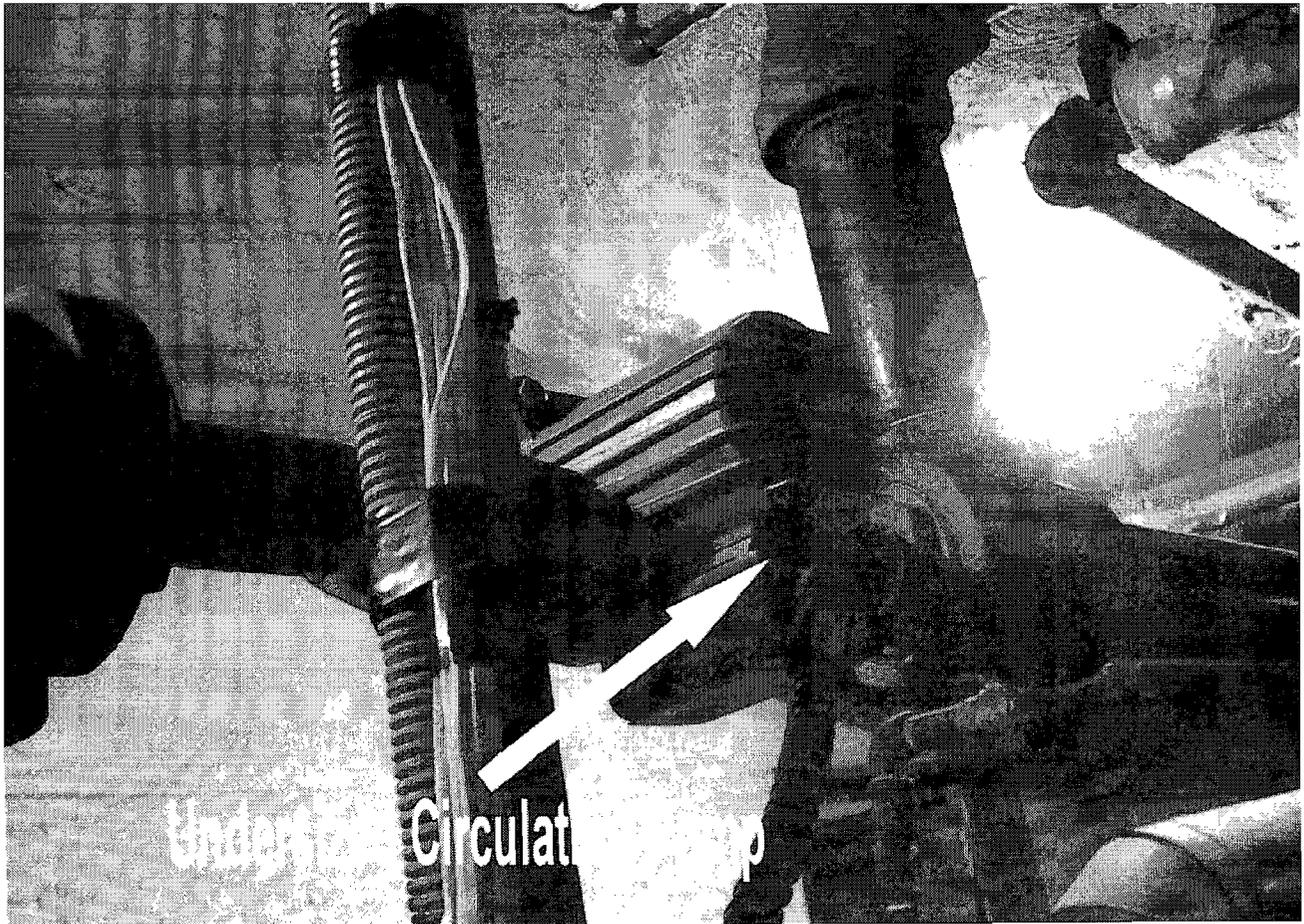
Circulator Pump

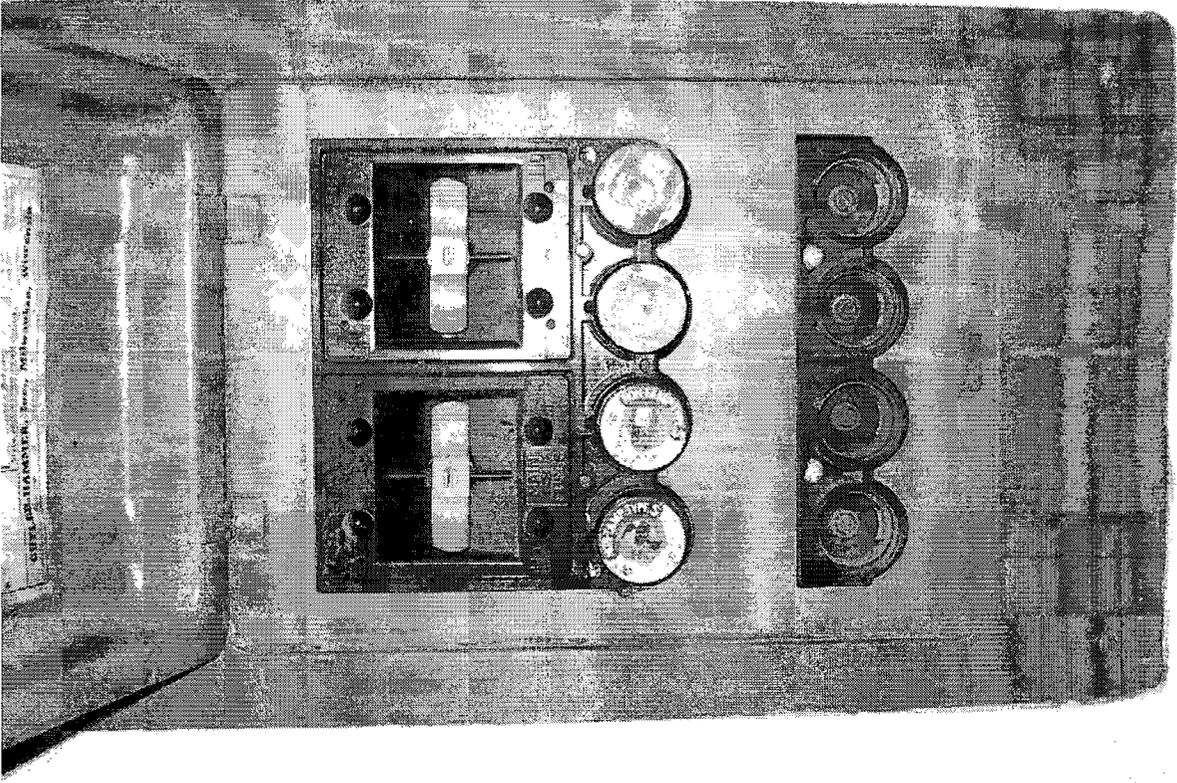
**Older Style Fuse Box**

The entire building must be upgraded electrically. A new 400 ampere 208/120 volt, three phase service is recommended.

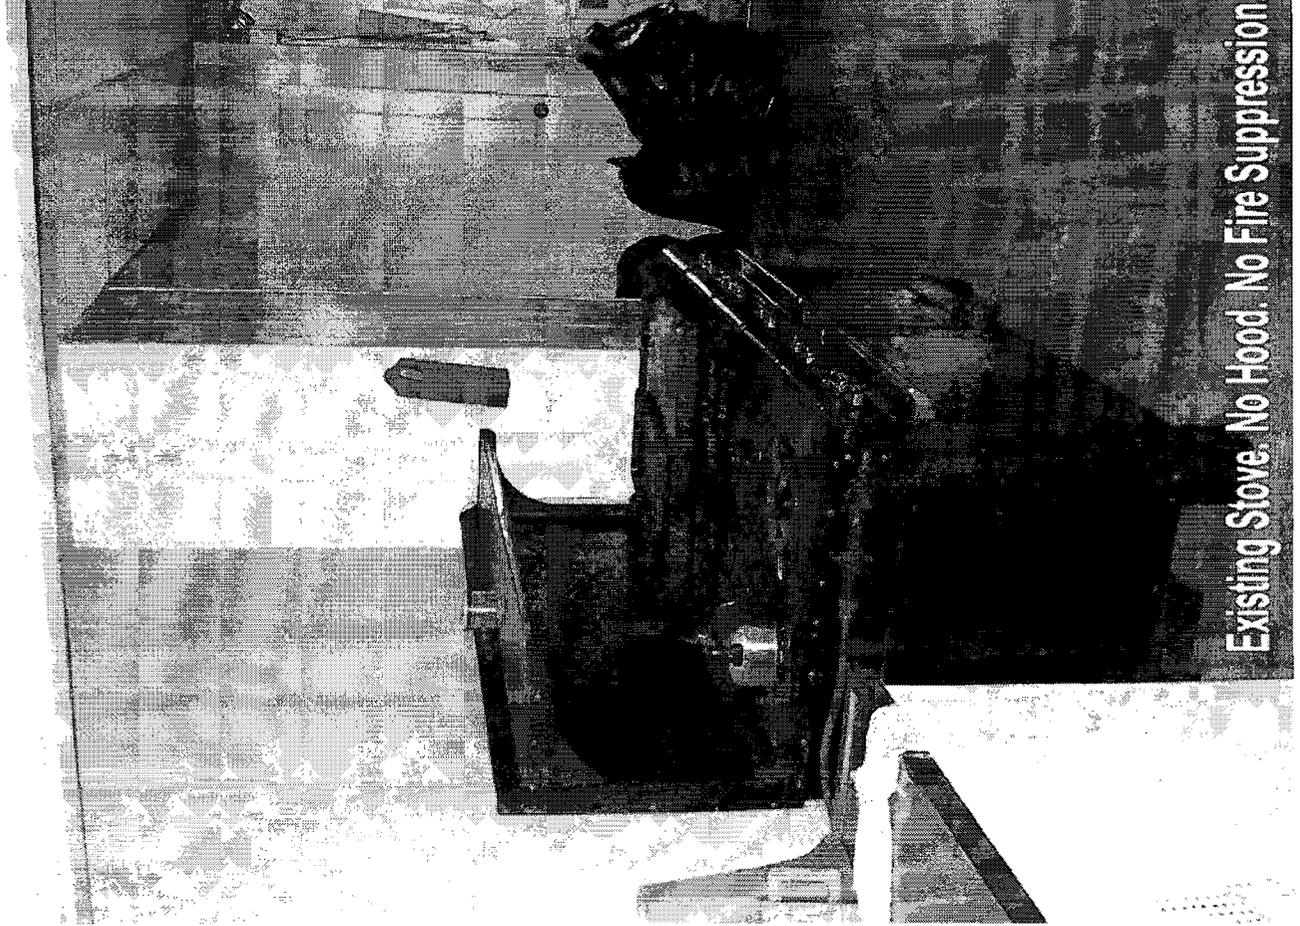
**Existing Stove. No Hood. No Fire Suppression.**

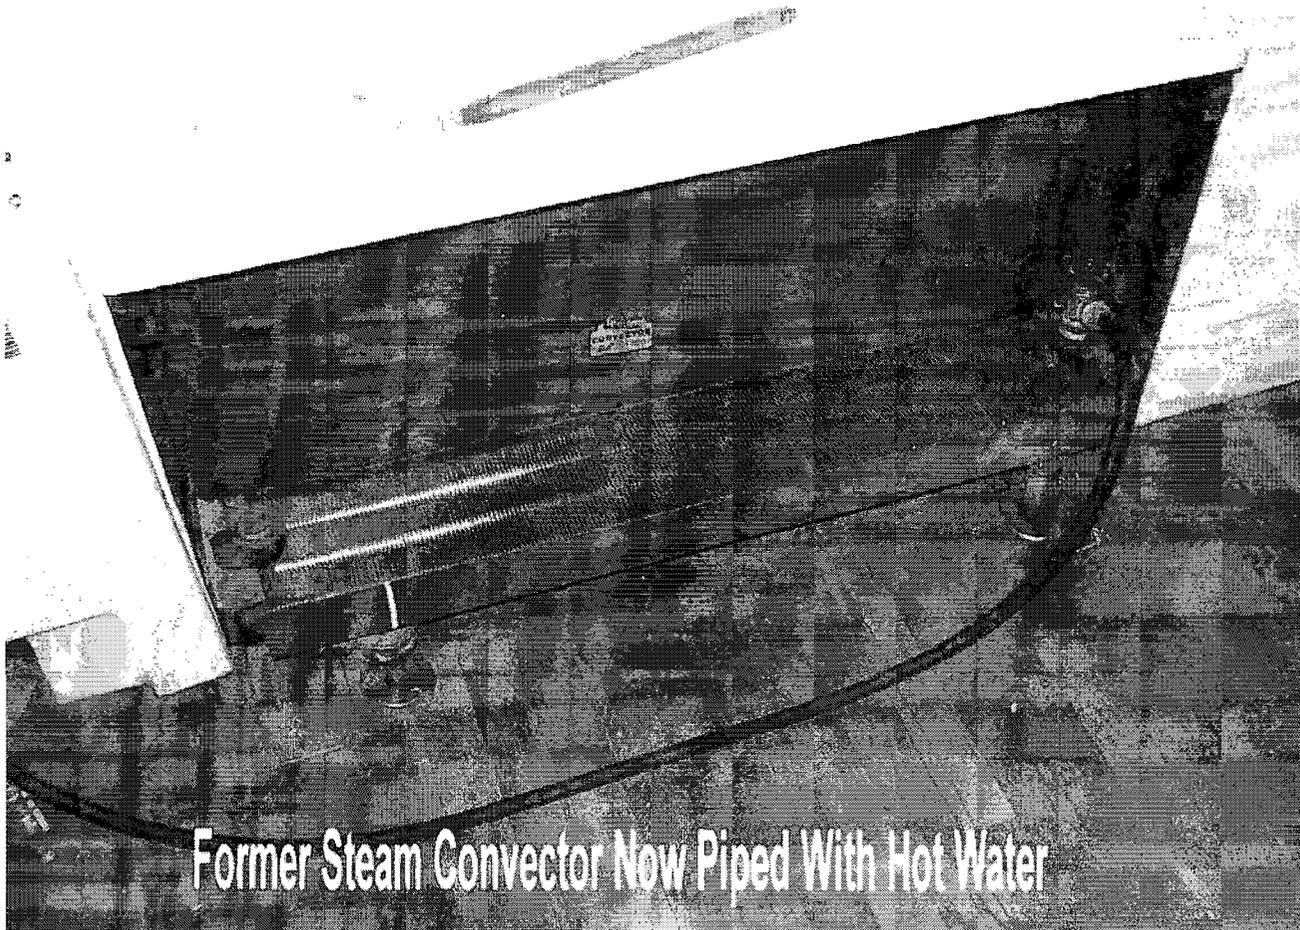
Former Steam Convactor Now Piped With Hot Water

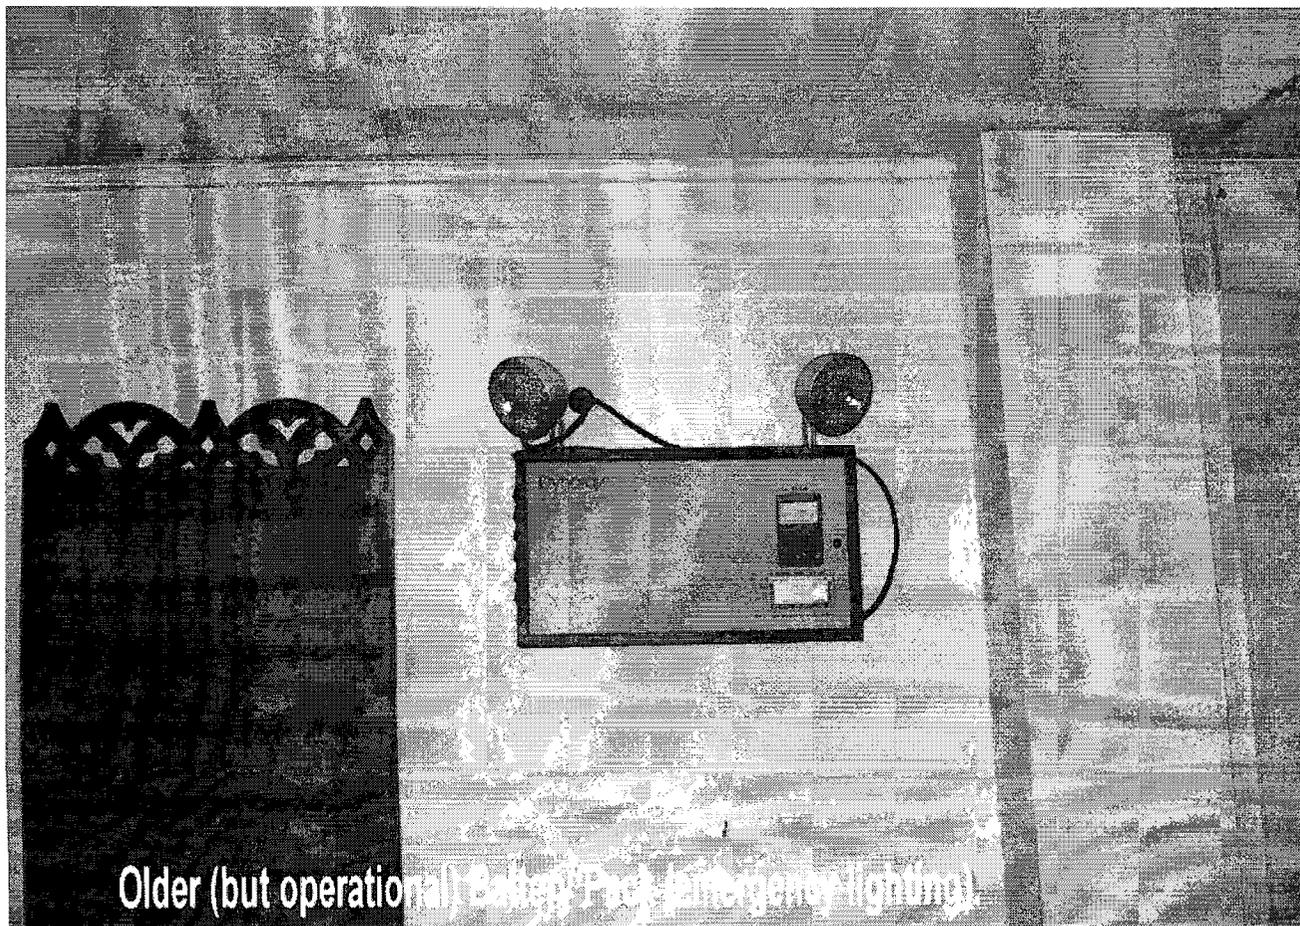
Emergency lighting is via battery operated wall packs. A minimal fire alarm system exists.

Older (but operational) Battery Pack Emergency Lighting

New fire alarm, emergency lighting, power distribution and lighting will also be required.

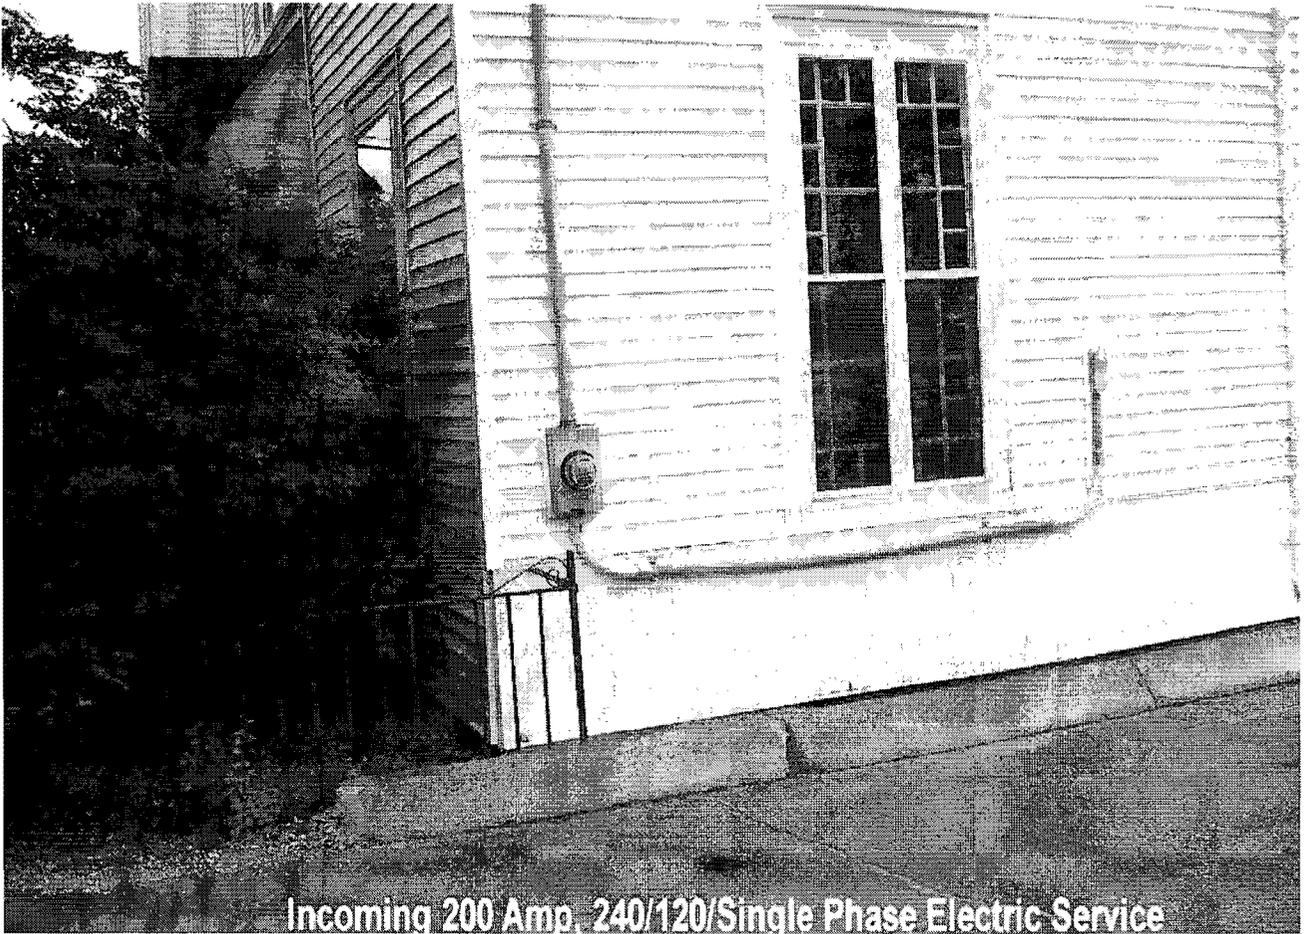
The building is currently served by a 200 AMP, 240/120 volt, single phase electrical service. Although adequate for the current use, it will not be capable of providing adequate power for an elevator and a modern HVAC system.

Incoming 200 Amp, 240/120/Single Phase Electric Service

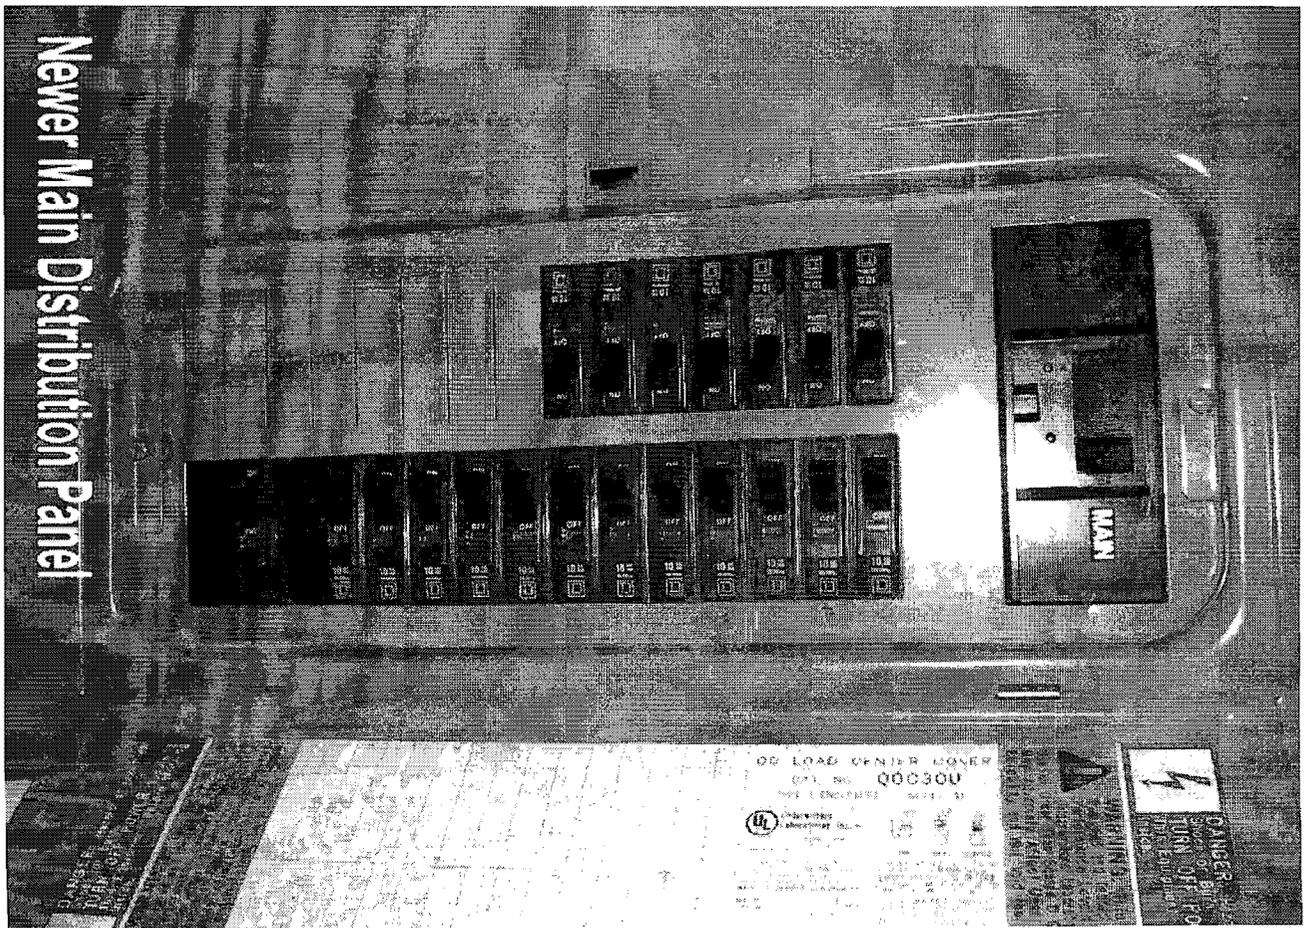
Newer Main Distribution Panel

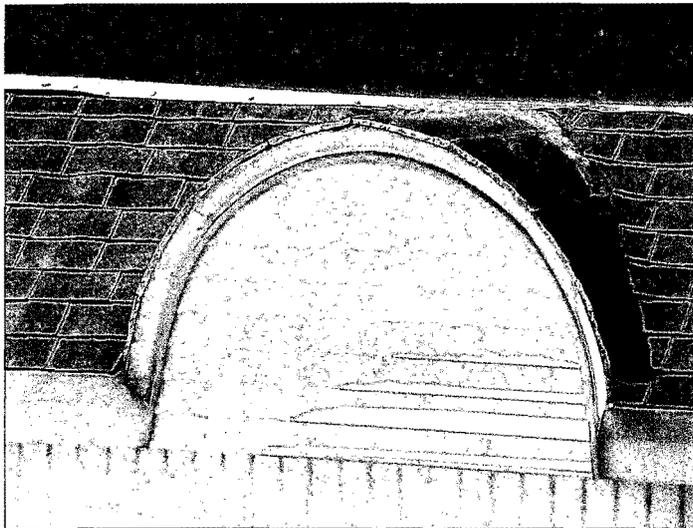
Closed half round window

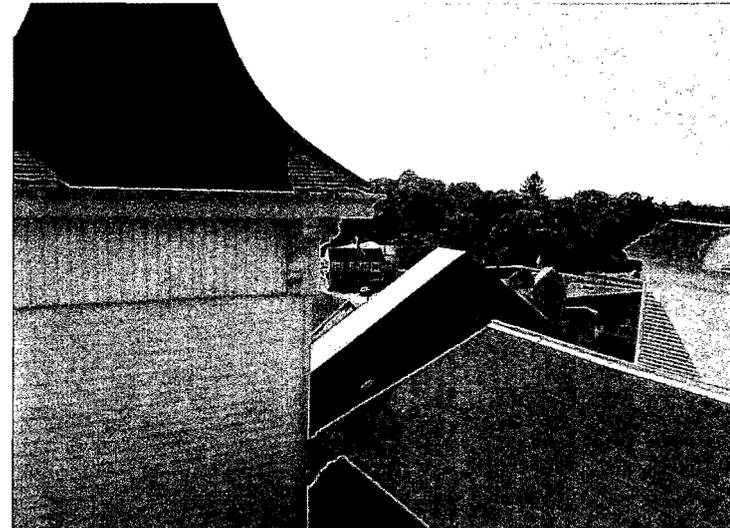
- Existing second level wood flooring to remain.
- Roof shingles appear worn in some areas, some cracking of the shingles observed. Existing asphalt shingle life remaining may be 1-8 years. There are water stains on the auditorium ceiling. Age of gutters undetermined. Newer architectural style shingles are on the Southwest tower roof. Bell tower roof has flat roof with roof hatch. Roof material unknown BUR or EPDM.

Roof shingle patch on gable

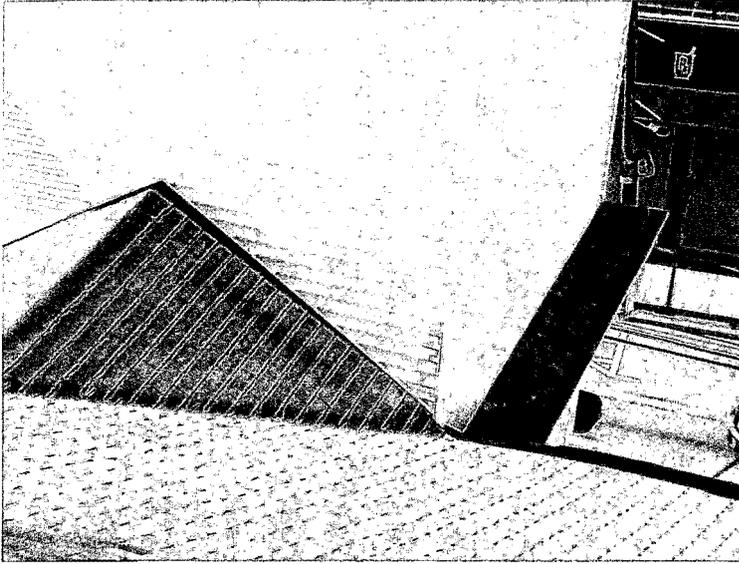
Asphalt shingle roof, metal flashing at gutter.

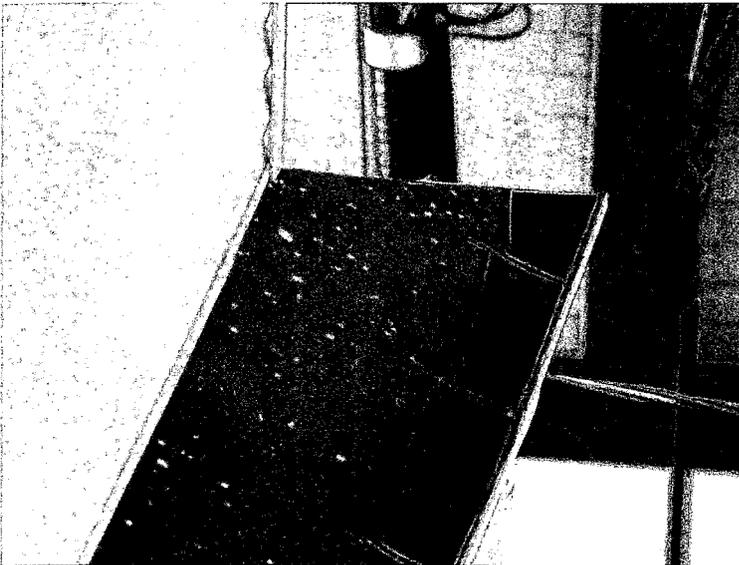
Metal flashing under vinyl siding

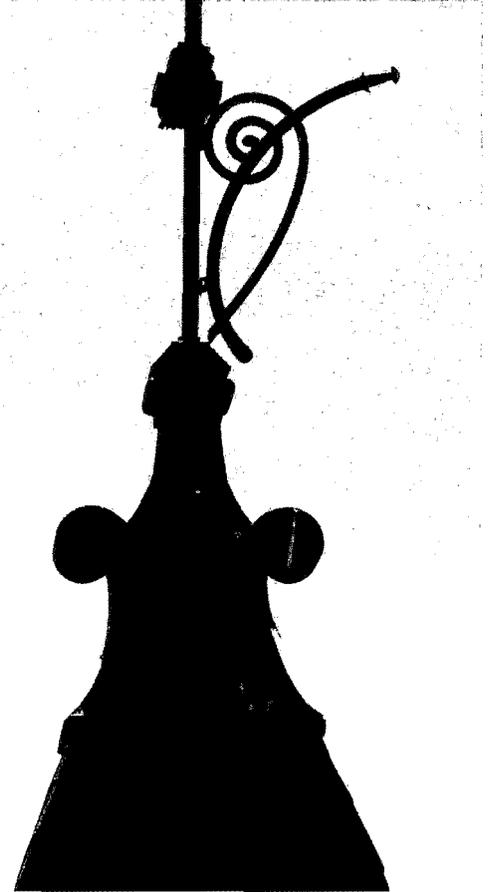
Rusting metal roof ornament at tower

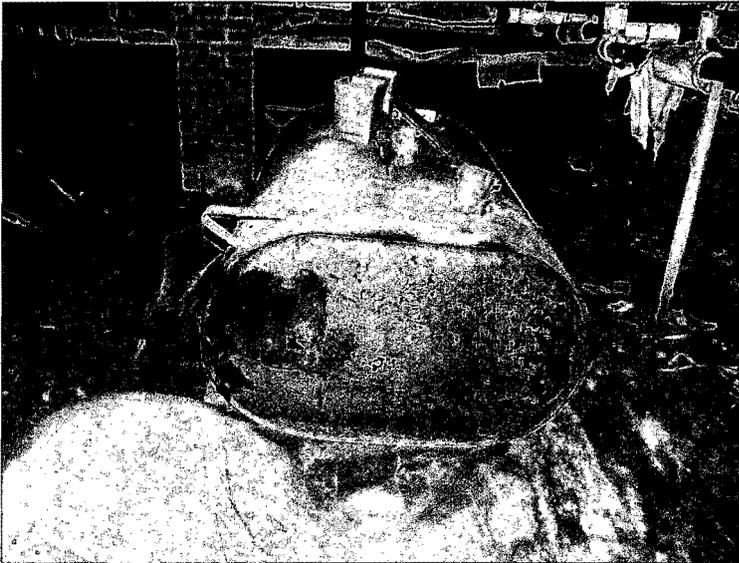
Abandoned Oil Tank

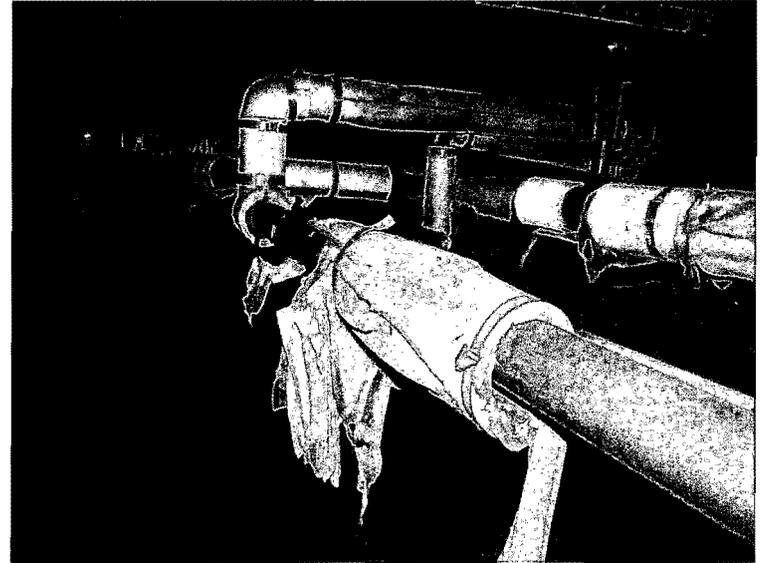
1. 9"x 9" Vinyl floor tile and mastic was found to contain asbestos. The ACM was found at various locations in the building including under carpet.
2. Pipe insulation was found to contain asbestos. The ACM was found at various locations in the building including above ceilings. The ACM was also found in the boiler room and crawl space.

Asbestos pipe wrap

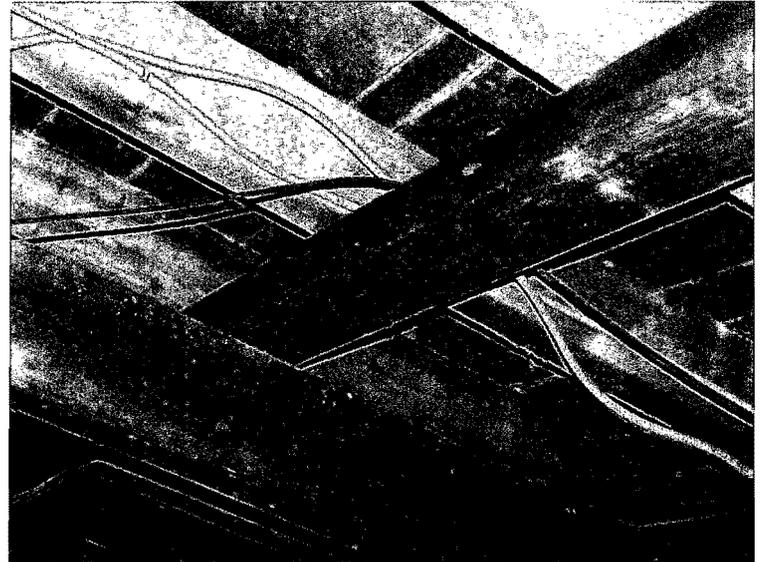
Temporary rafter support to first floor

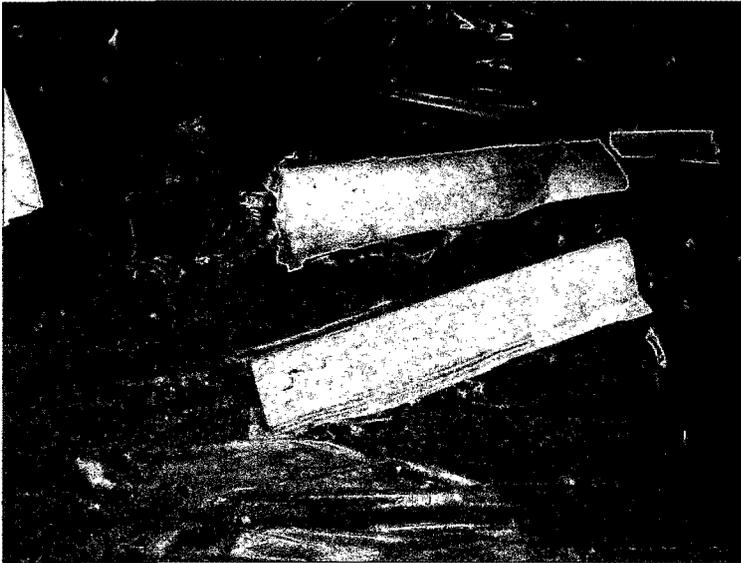
Asbestos pipe wrap next to steel lolly column

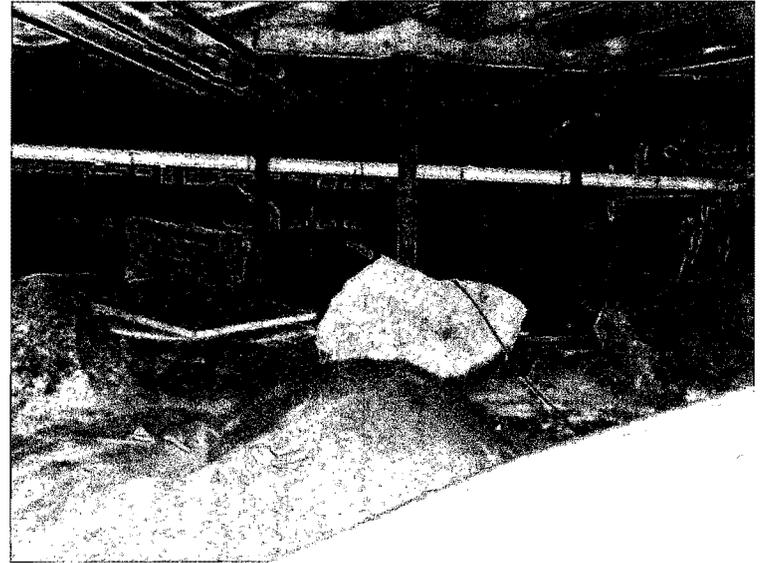
5. ACM debris was found in the crawl space. All stored items in the crawl space are contaminated with asbestos.
6. Transite siding was found to contain asbestos. The ACM was found on the exterior of the original building.

Crawl space

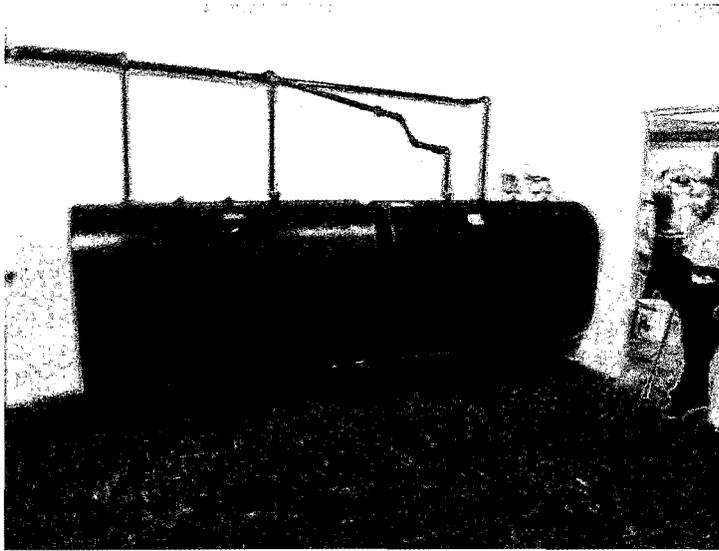
Existing 275 Gal steel oil tank

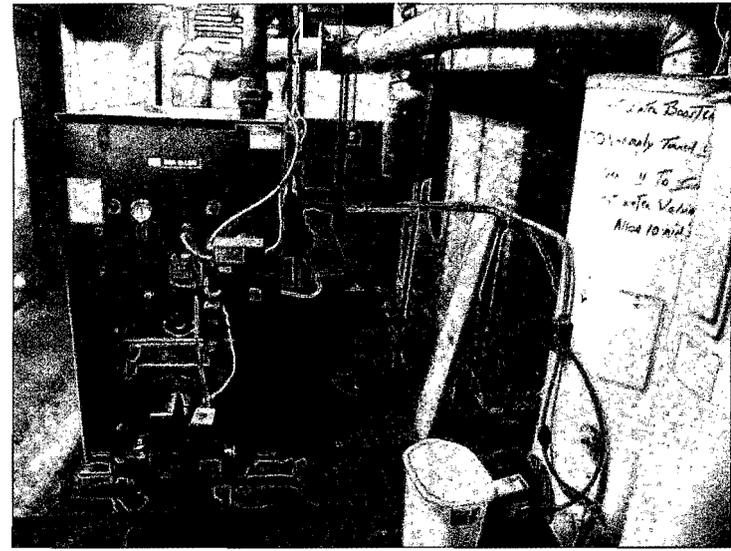
Although the boiler can be reused, it is not particularly efficient. Modern, gas fired condensing boilers can increase efficiency by 12-15 percent.

Existing Weil McLain boiler (one)

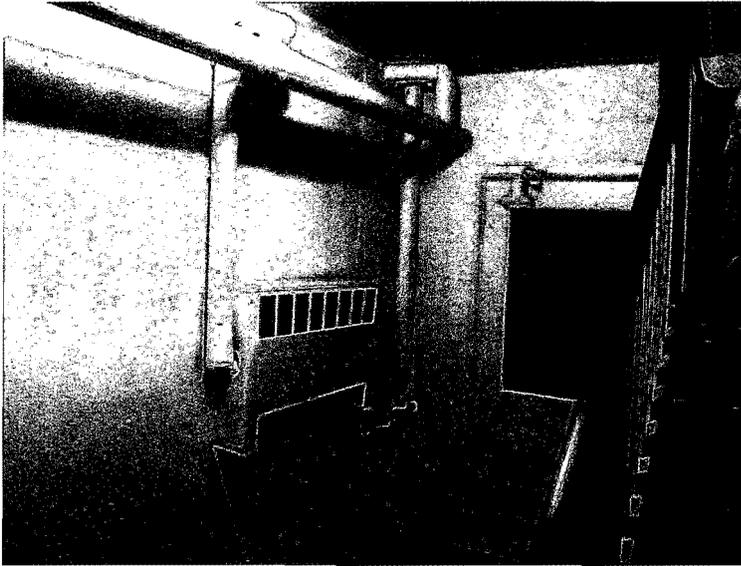
Asbestos pipe wrap on supply and return piping

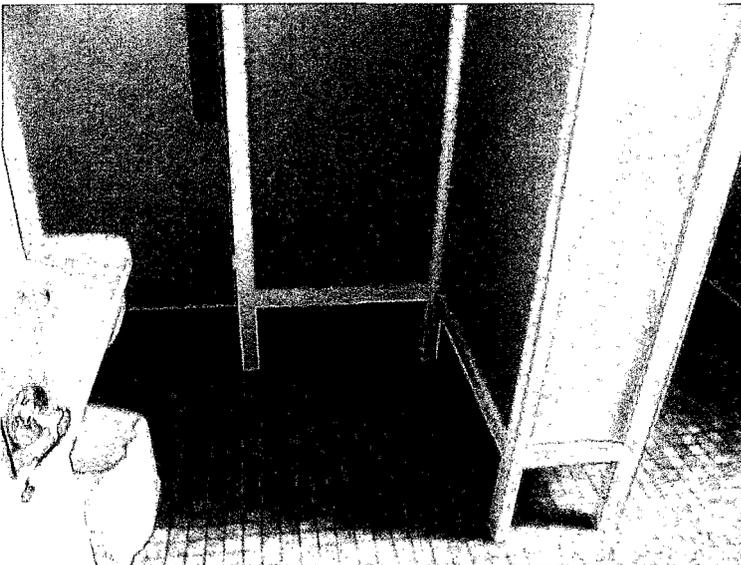
Non-accessible toilet stall

- Provide accessible entrance, ramp, toilet rooms, drinking fountains, telephone, and kitchen and elevator vertical access.
- Patch and repair walls, ceilings, trim, doors, and miscellaneous details.

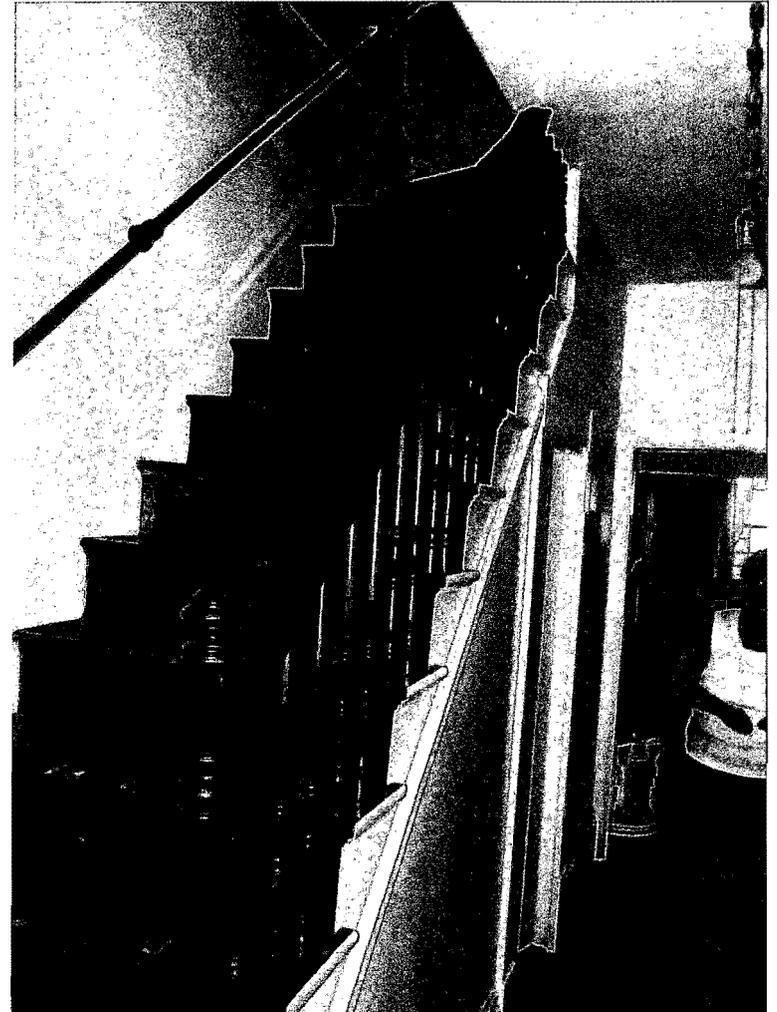
Rear stair egress at kitchen

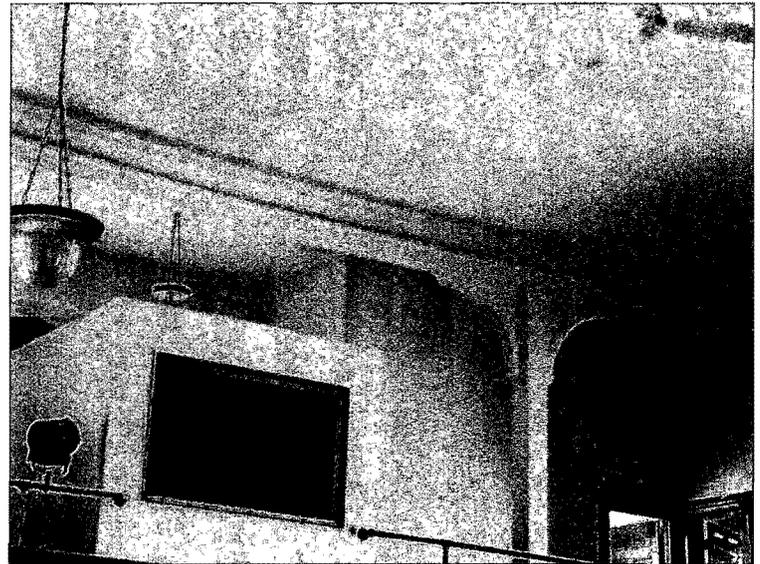
There are deflections in the auditorium ceiling one bay inside the two end walls of the auditorium. The deflections are due to the fact that the beams supporting the ceiling at these two locations are too shallow. Cracks in the ceiling above the two columns which support the central beam indicate the inadequacy in the depth of the supporting beams.

Ceiling with slight beam deflection

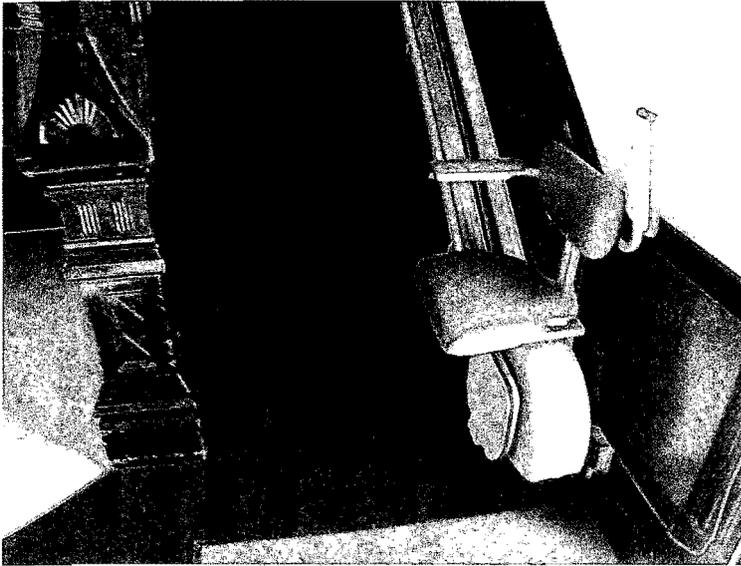
- Both interior main stairs are in good condition although the stairs are leaning toward the interior load bearing wall, that condition could remain as having no structural consequence, only aesthetic concerns. However the floor loading for Town use is 100lbs and the structure will have to be reinforced. The load bearing wall deflection can be adjusted to level the floors and stairs.

Accessible stair lift on settling staircase

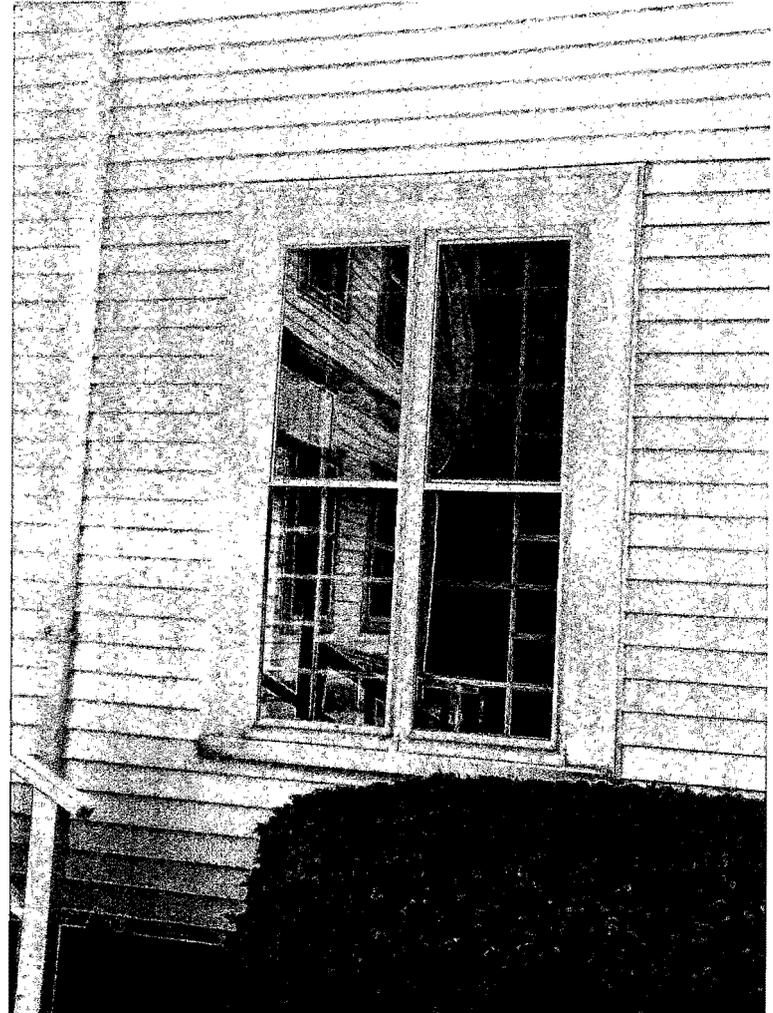
Storm windows over mosaic glass windows

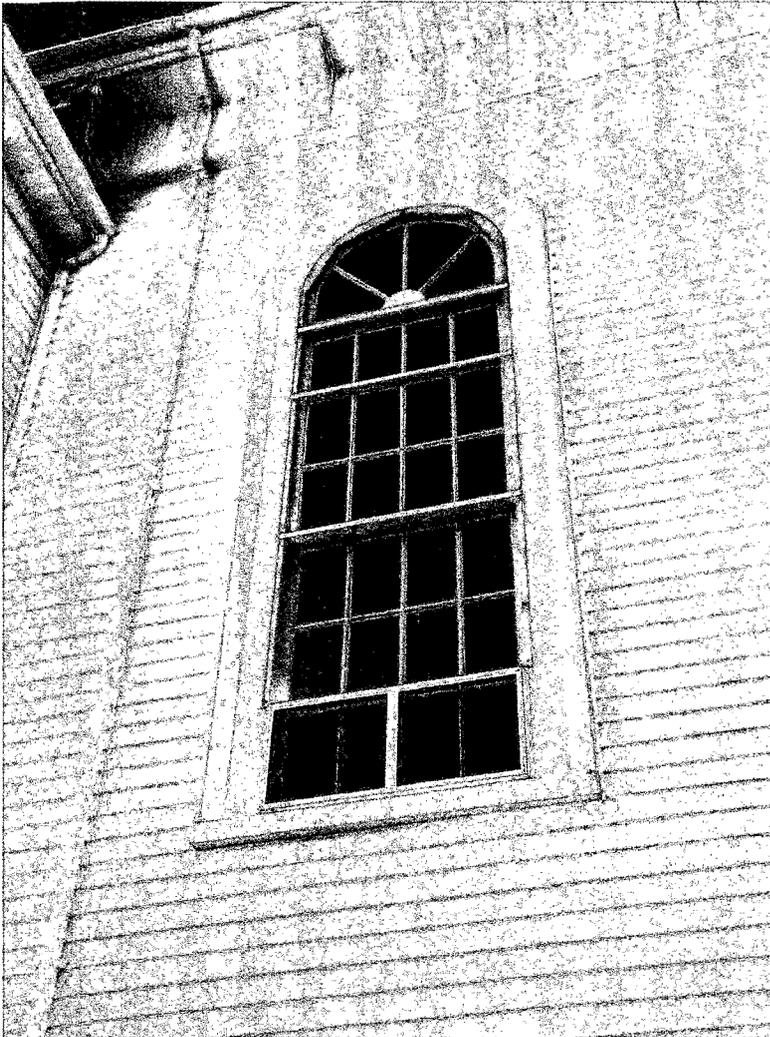
Storm windows over framed arch window
