October 10, 2008

Project:
Needs Analysis for Town Hall and Fire Station
Town Hall, and Central Fire Station
Whitman, MA

Town of Whitman
Needs Analysis for Town Hall and Fire Station

Existing Conditions
March 2008

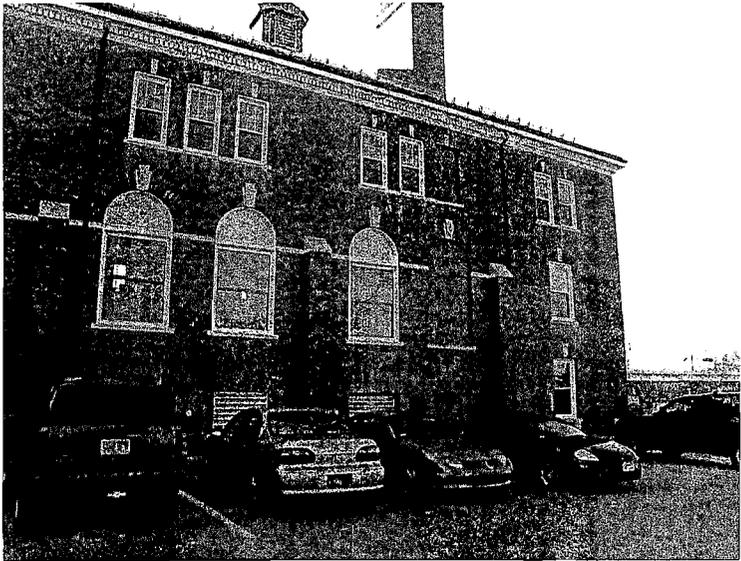
Paint leaching under sills onto brickwork.

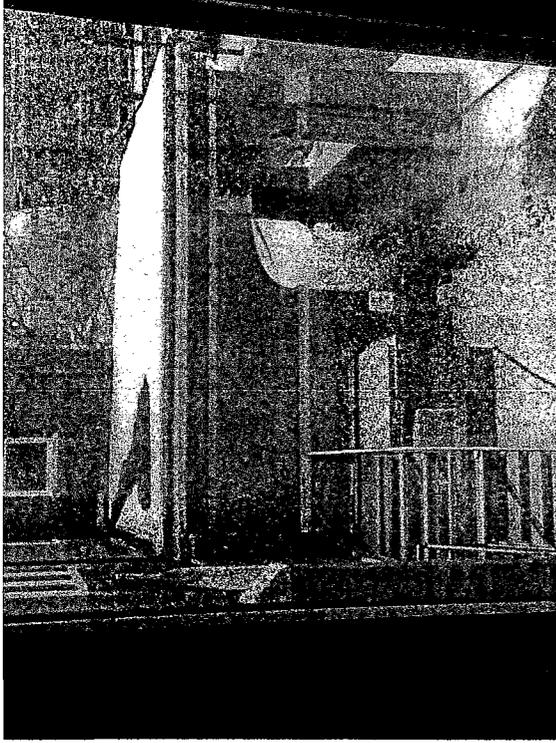
Port cochere and deteriorated metal flashing at flat roof.

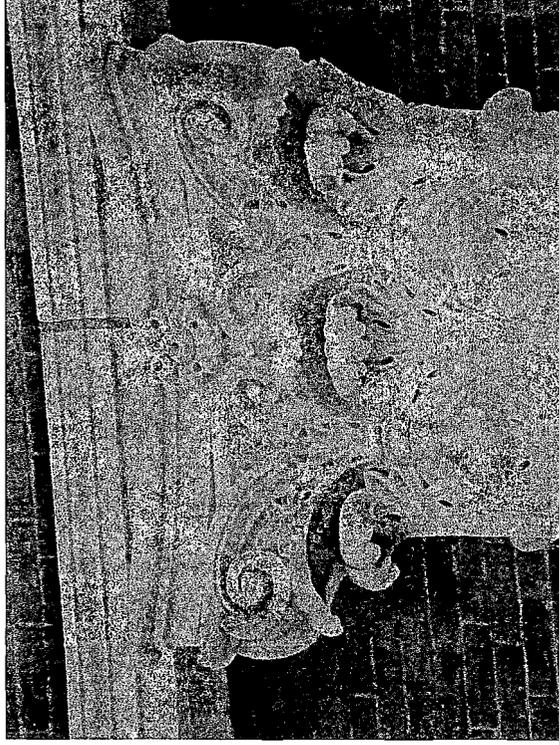
Corinthian pilaster capital.

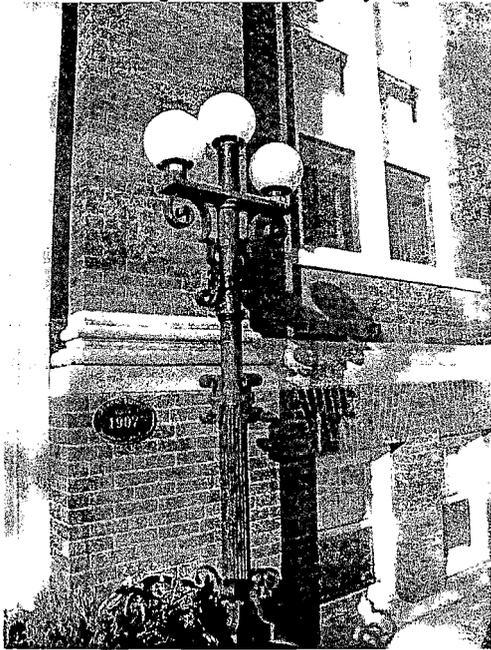
Original light post next to 1907 marker.

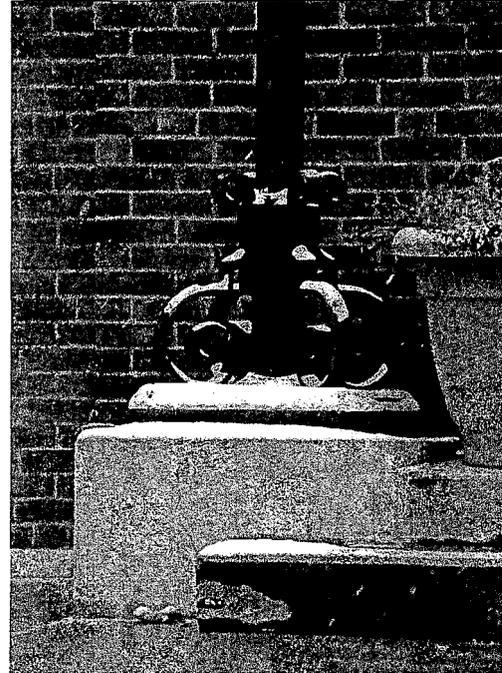
Cracked concrete light base.

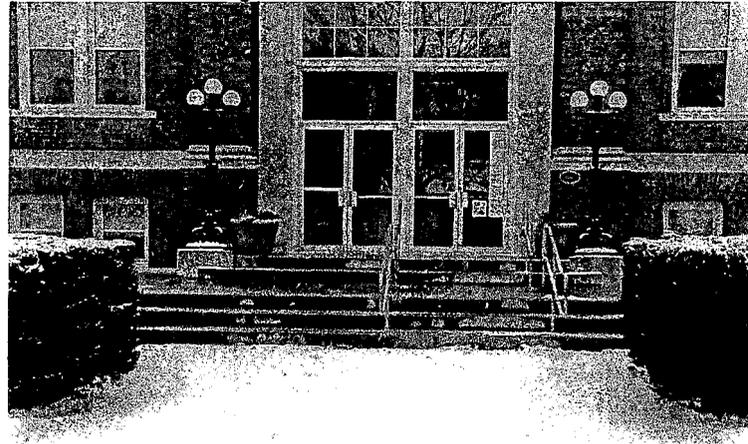
wood doors have been replaced by aluminum storefront doors.

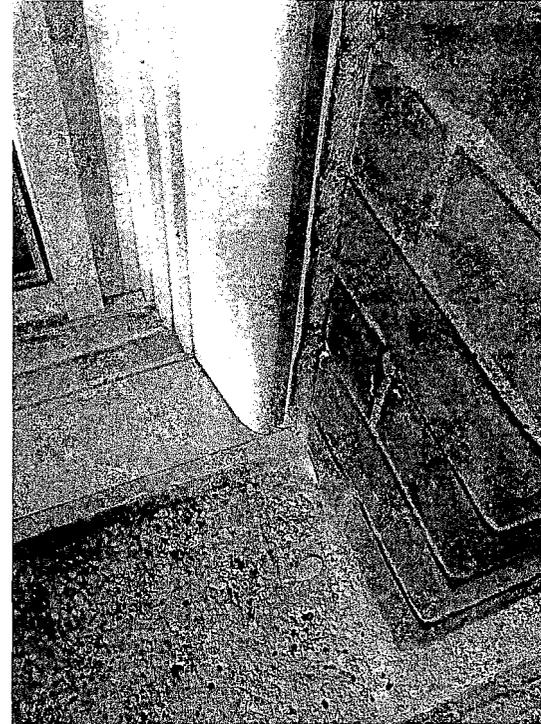
Deteriorated 20 year old window caulk should be replaced.

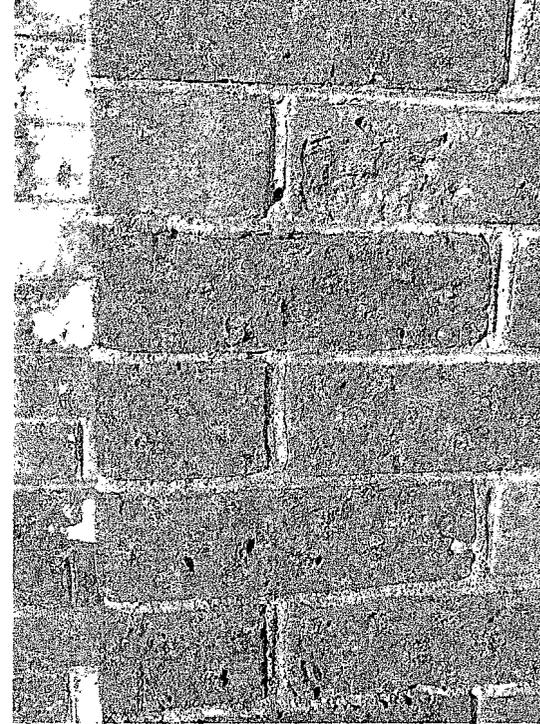
spalling face brick and cracked mortar joints.

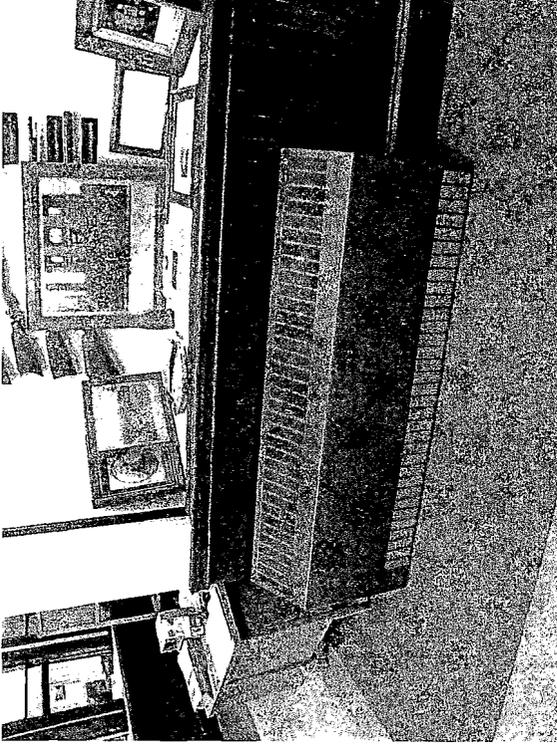
Heating system cabinet blocking display case.

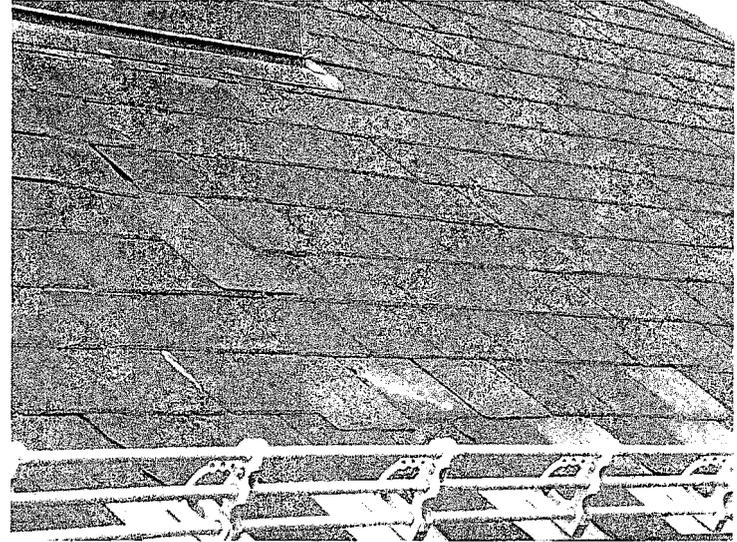
Loose slate.

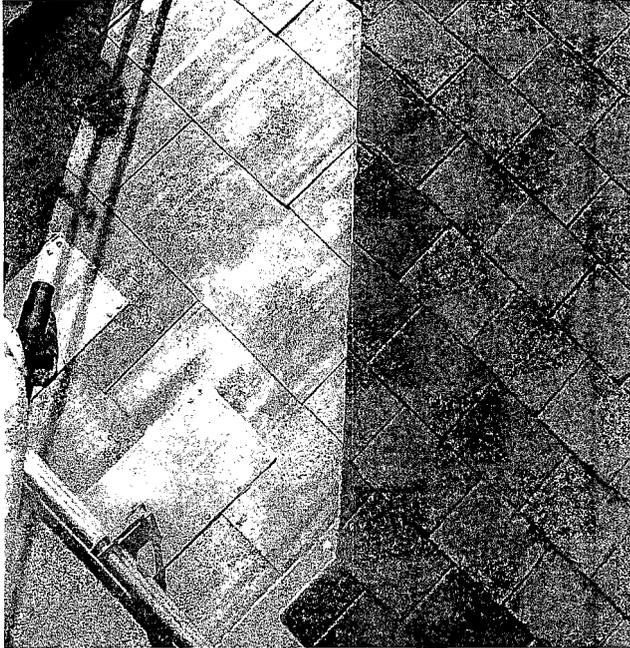
Roof valley flashing detail with mismatched replacement slate above east entrance

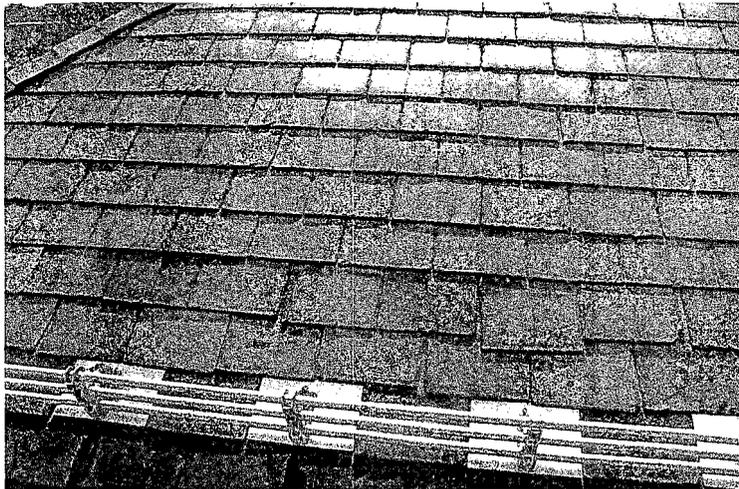
Loose and broken slate.

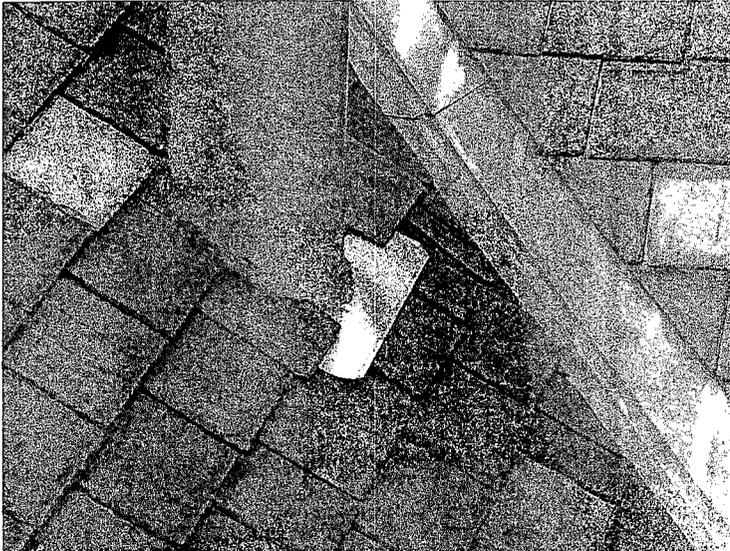
Loose cracked slate.

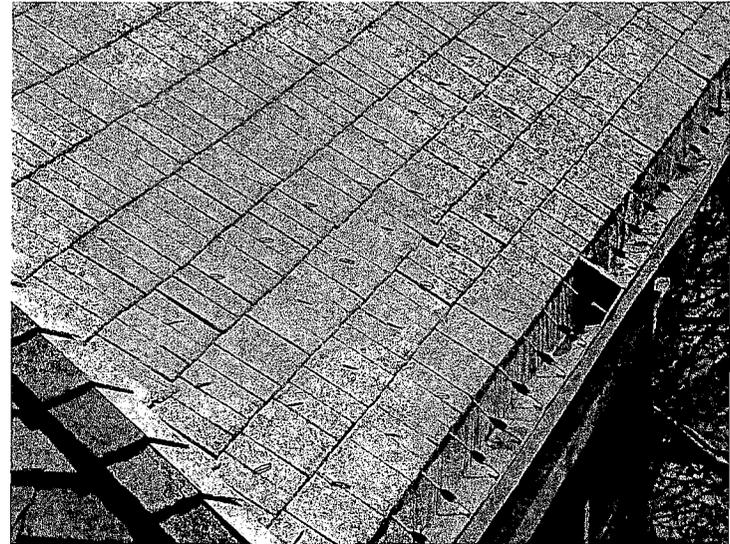
Southeast elevation. Detail of cracked loose slate with failed snow guard.

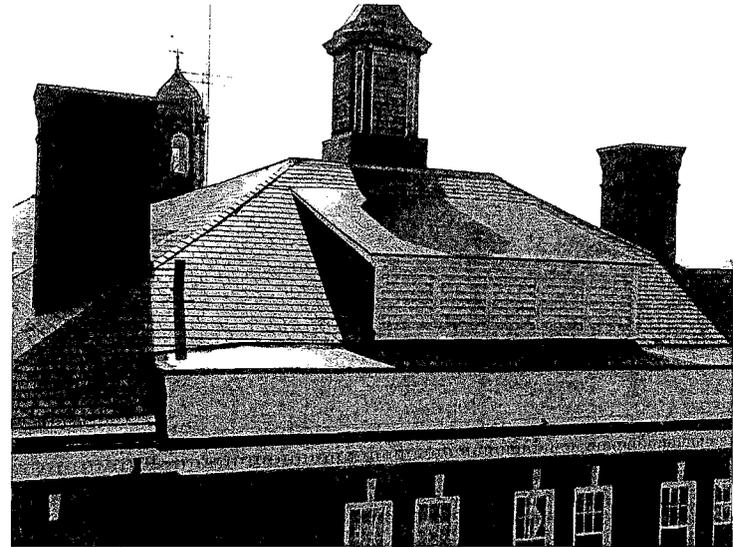
North elevation with EPDM flat dormer roofs.

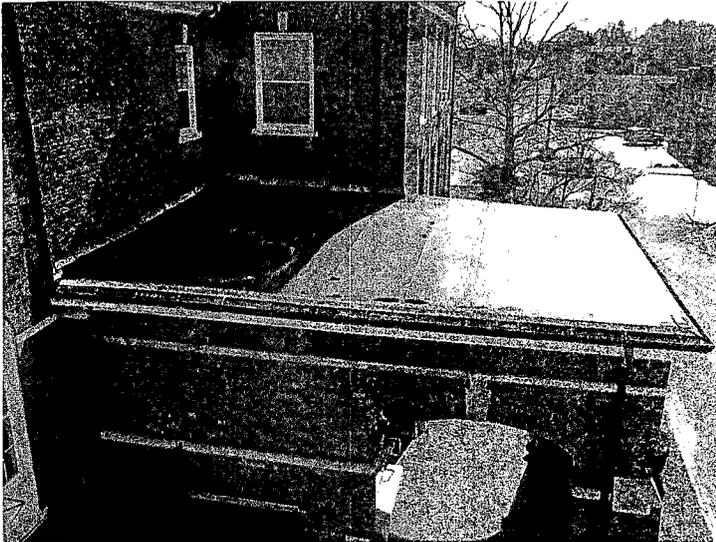
Porte cochere flat EPDM roof with standing water and failed gutter system allows the roof water to penetrate into brick structural wall causing brick spalling and efflorescence.

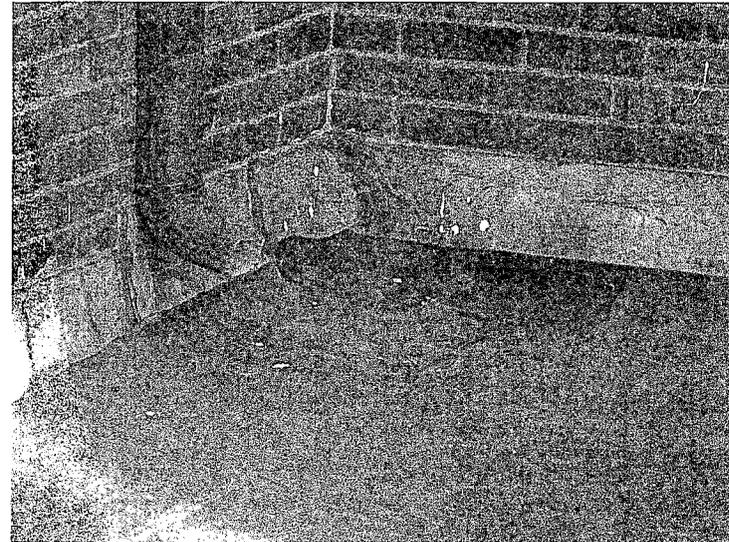
Deteriorated wall to roof flashing @ porte cochere.

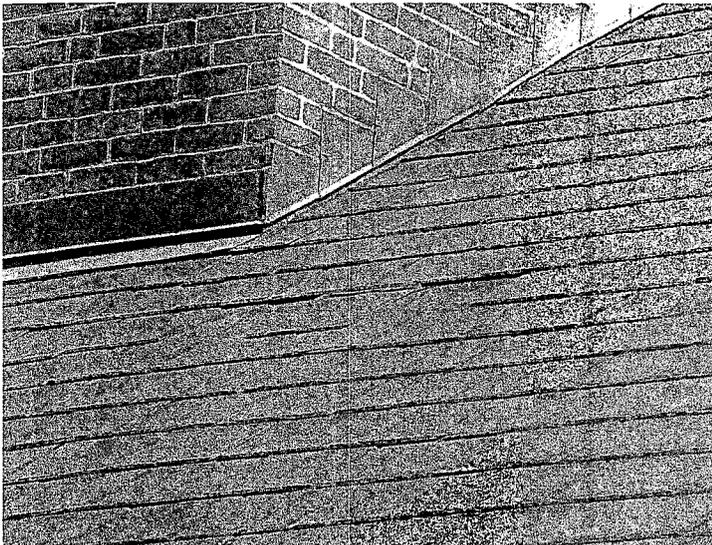
Loose and missing slate.

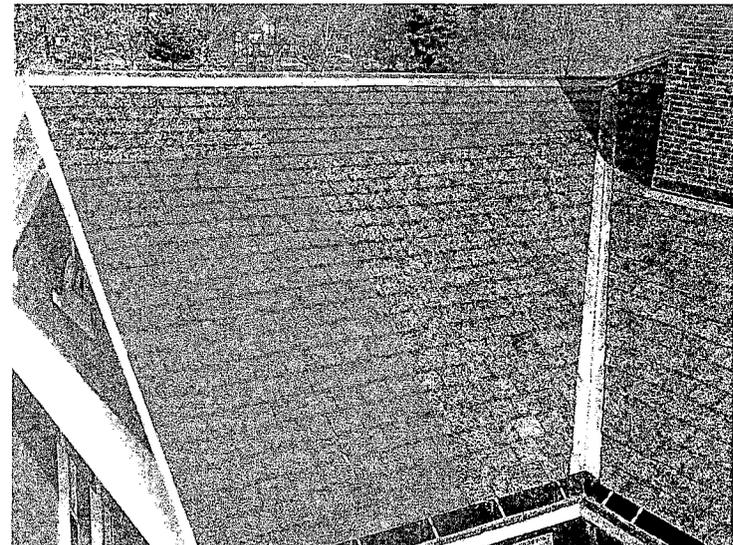
Scattered slate repairs on north west gable.

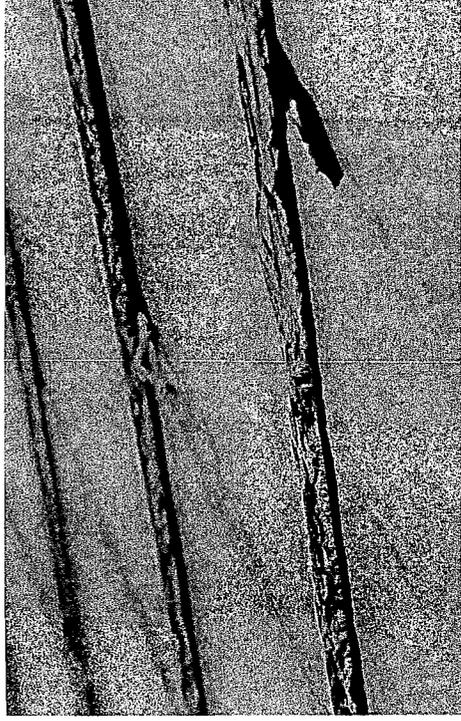
Rusting nails and original snow guard rail
Showing loss of attachment.

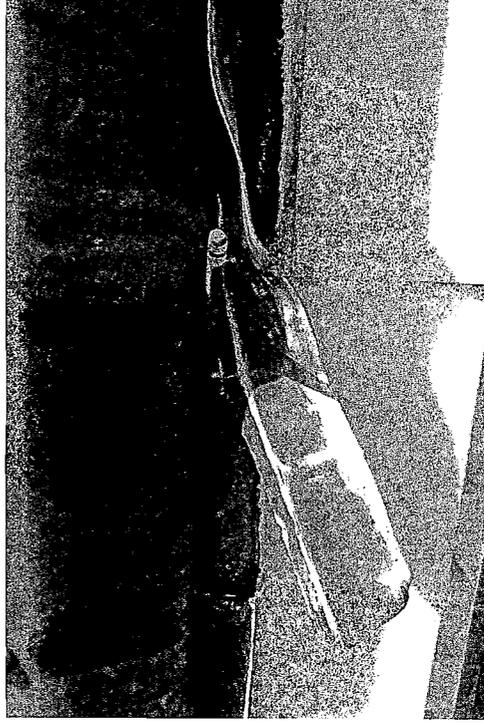
Small lead flashing inserted under gutter, allowing metal cornice. To accelerate rusting process. Full extent of damage unknown.

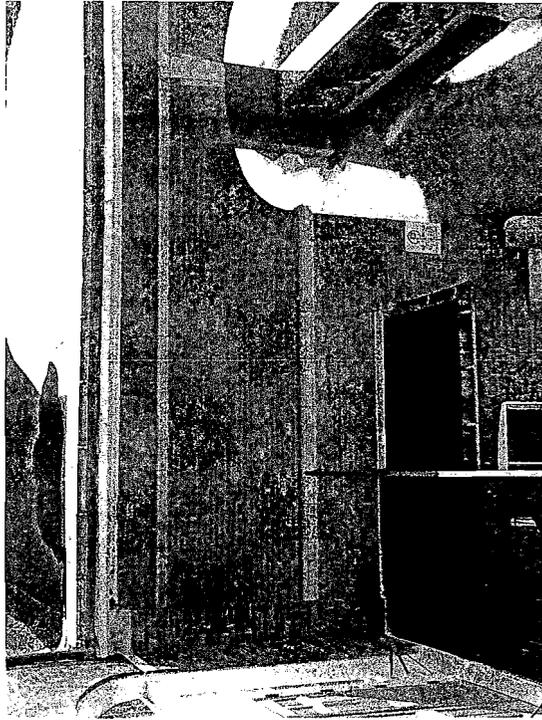
Roof water entry allowed brick efflorescence and spalling to occur.

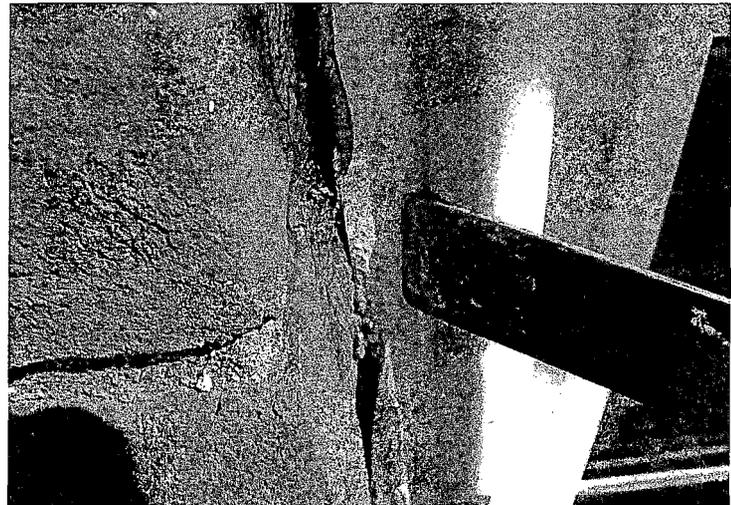
Water entry allowed at brick mold. Flat edge of Metal return of window frame causing opening and sealant failure
